**Coronado Cays HOA (including  
Antigua Court & Kingston Court)**

PROJECT NAME  
 CORONADO CAYS BULKHEADS  
 ANTIGUA COURT (CORONADO CAYS HOA)

Field Survey Dates: May 18, 19, & 20, and June 25, 2021

TERRACOSTA CONSULTING GROUP 3805 MURPHY CANYON ROAD, SUITE 200 SAN DIEGO, CA 92131 858.973.8900	FIGURE NUMBER <b>B-2</b>
CORONADO CAYS BULKHEADS <b>KINGSTON COURT (CORONADO CAYS HOA)</b>	PROJECT NUMBER T2904.070.001

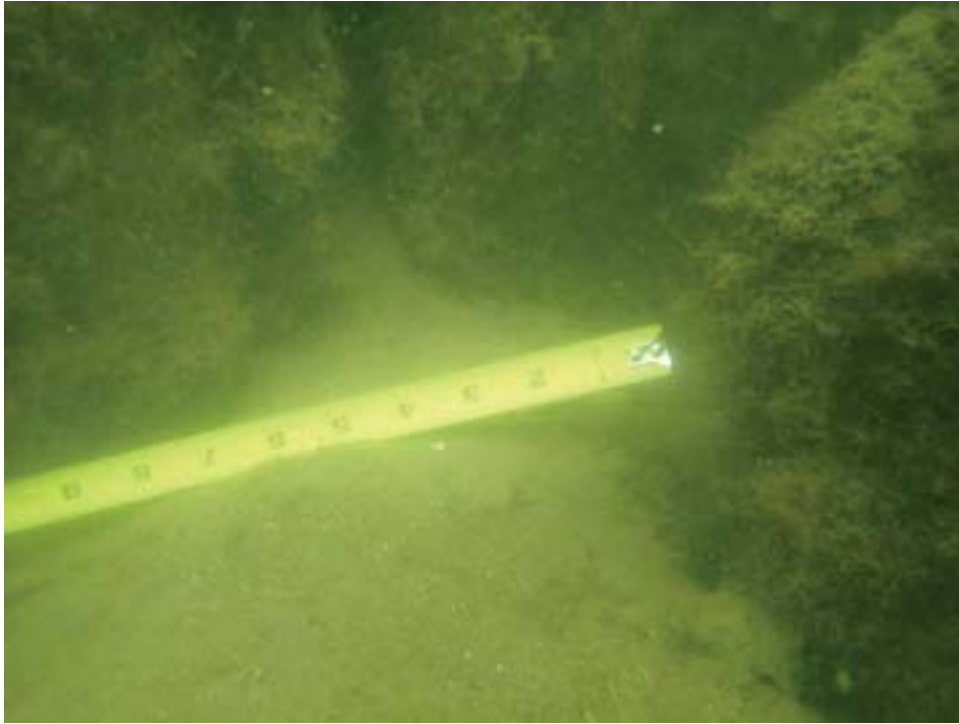
Photo 1: Antigua Court. Talus pile just south of Gangway 2 (joint approx.. 10 feet southerly of gangway).

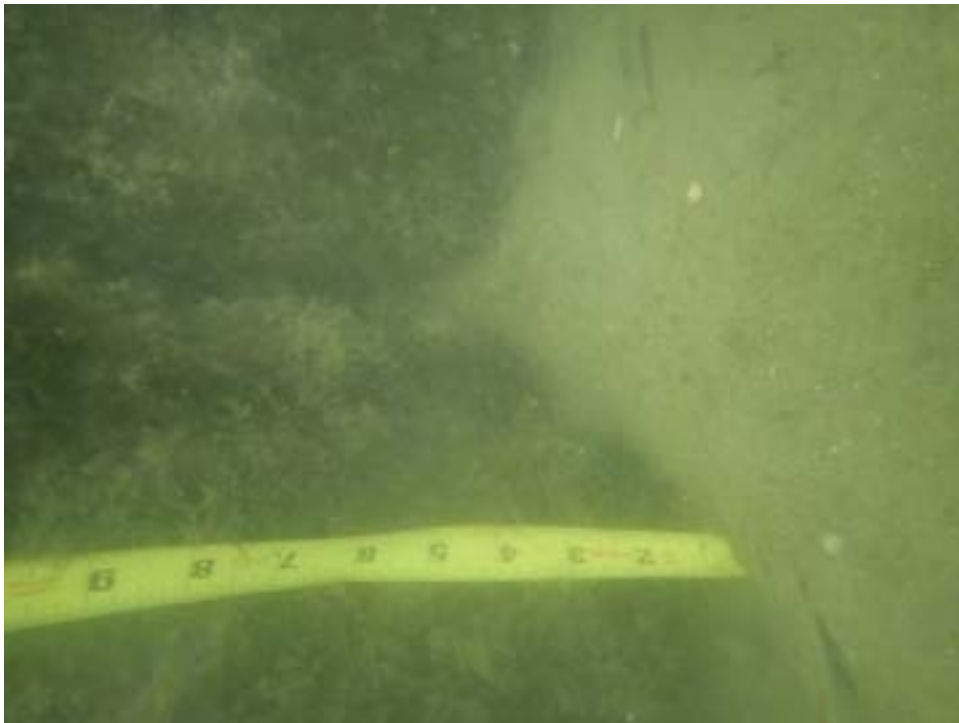
Photo 2: Antigua Court. Talus pile just south of Gangway 2 (joint approx.. 10 feet southerly of gangway).

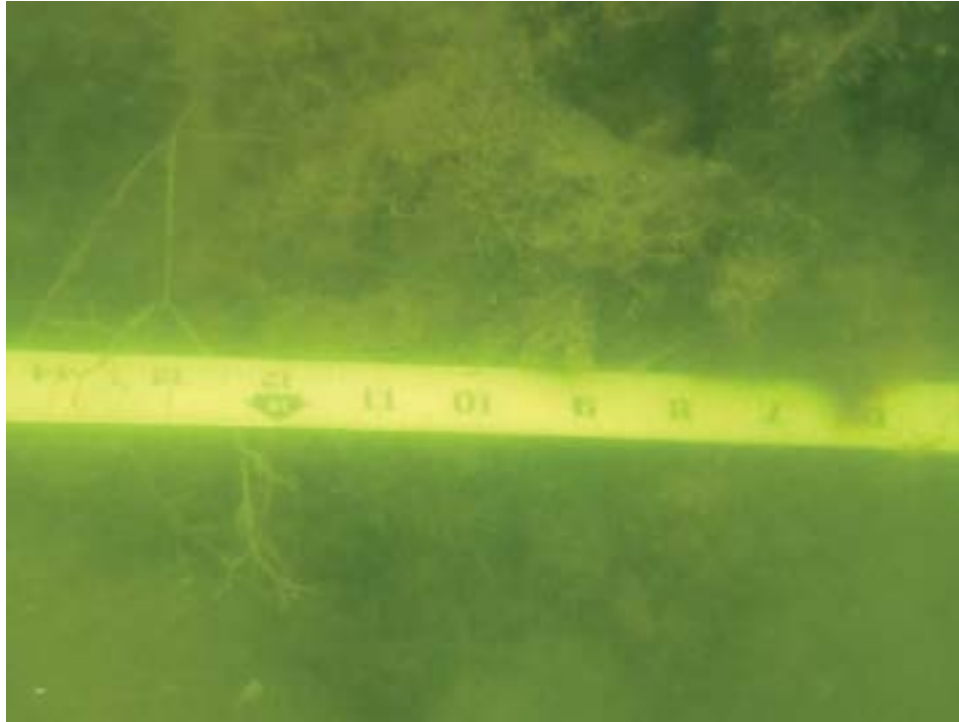
Photo 3: Antigua Court. Talus pile just south of Gangway 4. Although not visible in photo, joint width is 1 inch.

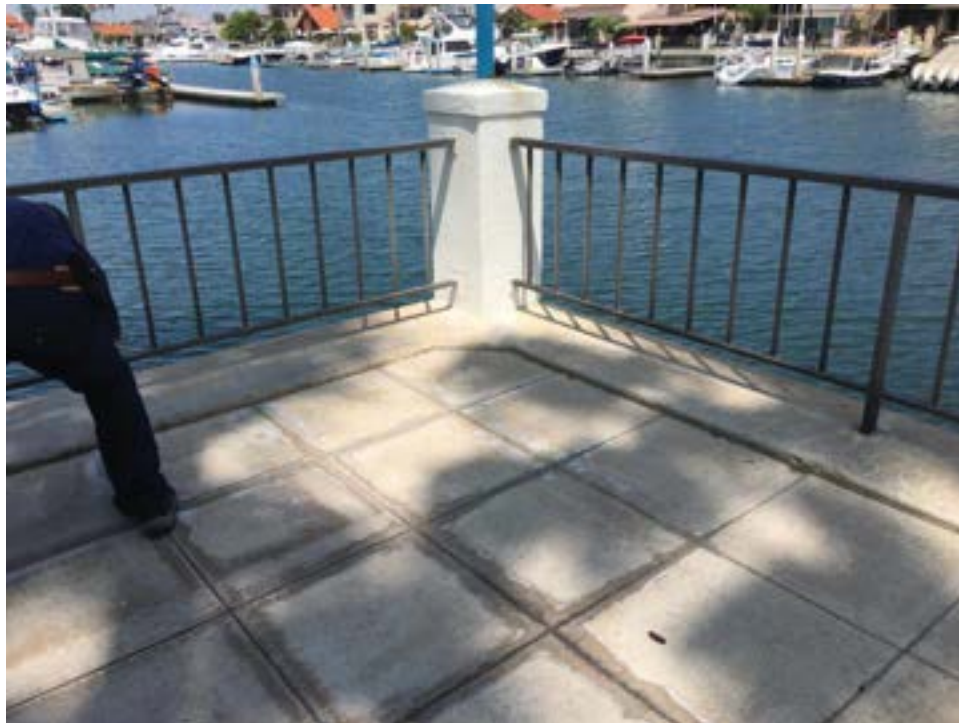
Photo 4: Antigua Court. Checking for voids under sidewalk at common area, northwest corner of Antigua Court.

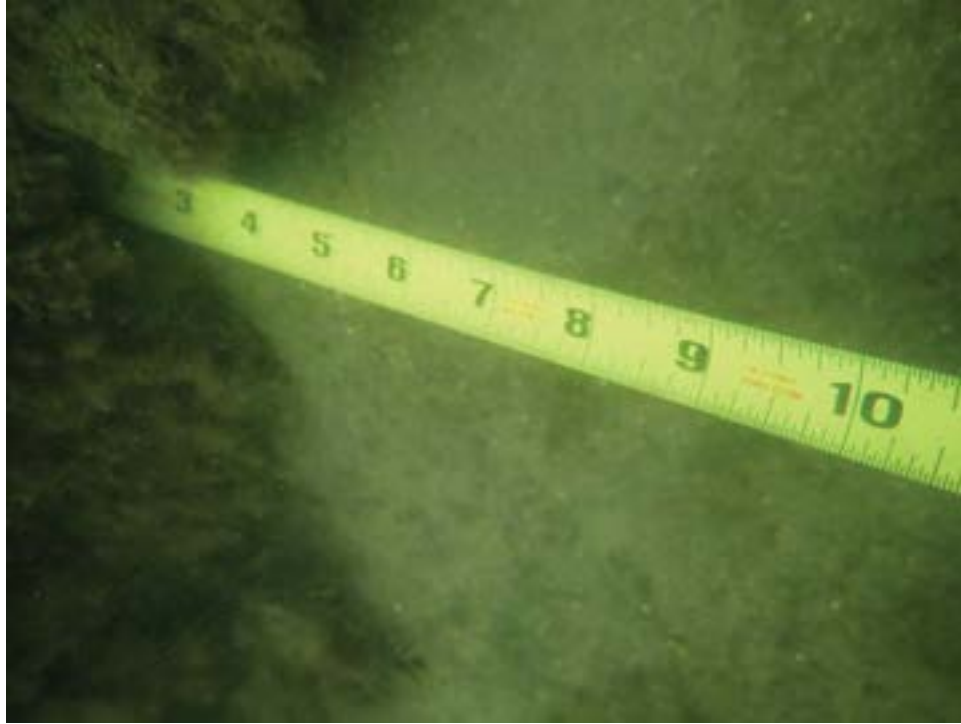
Photo 5: Antigua Court.  
6-inch-high talus pile at northwest corner joint

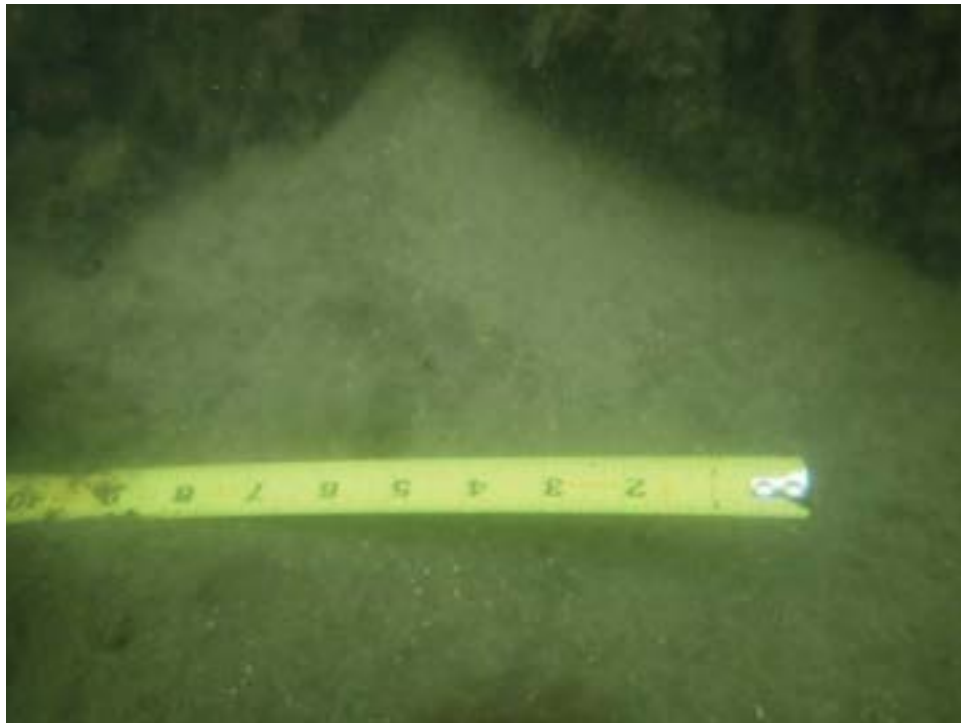
Photo 6: Antigua Court.  
6-inch-high talus pile at northwest corner joint

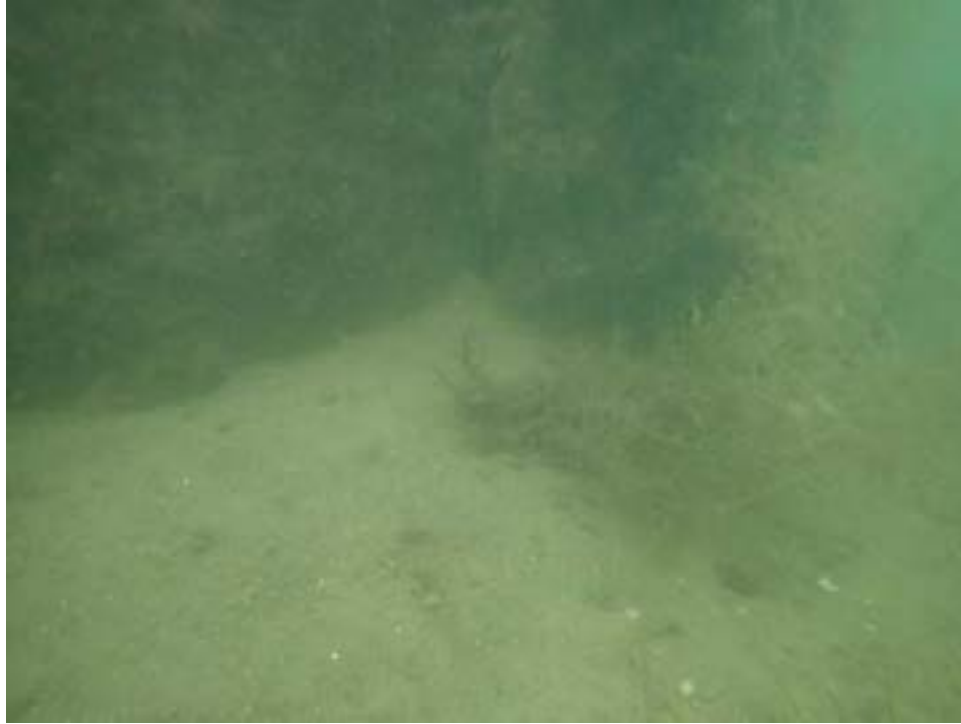
Photo 7: Antigua Court.  
6-inch-high talus pile at northwest corner joint

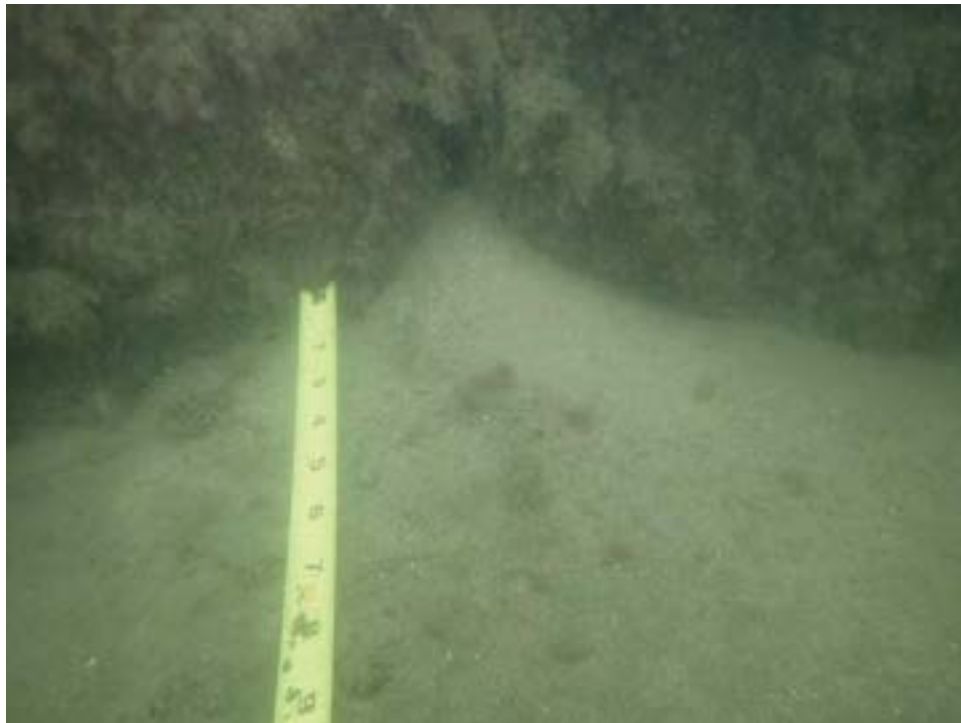
Photo 8: Antigua Court, 20 feet east of northwest corner.  
6-inch-high talus pile.

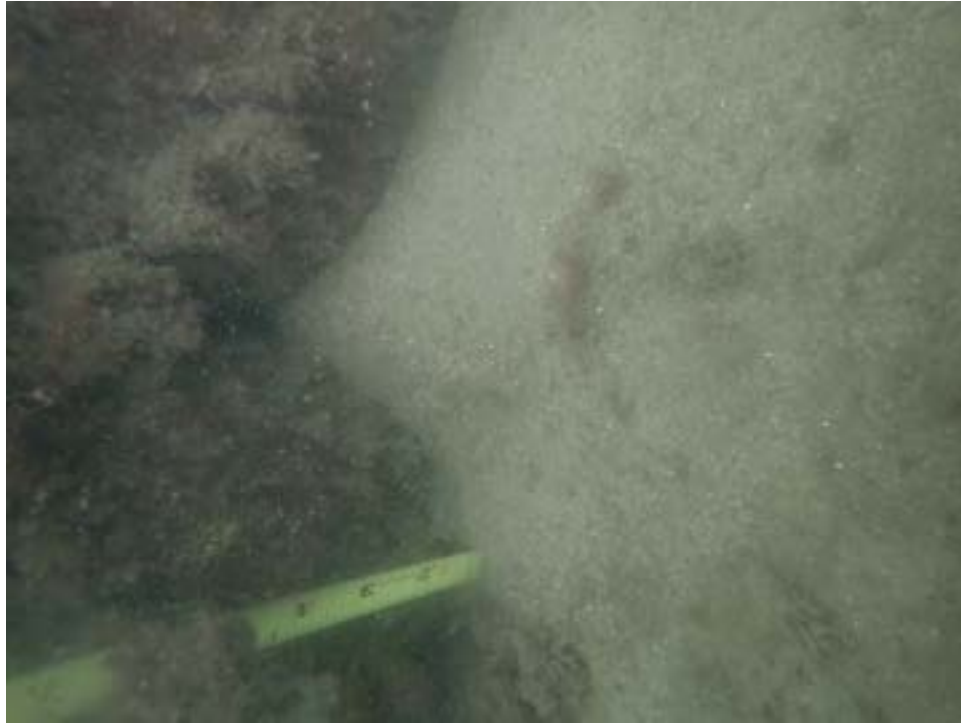
Photo 9: Antigua Court, 20 feet east of northwest corner.  
6-inch-high talus pile.

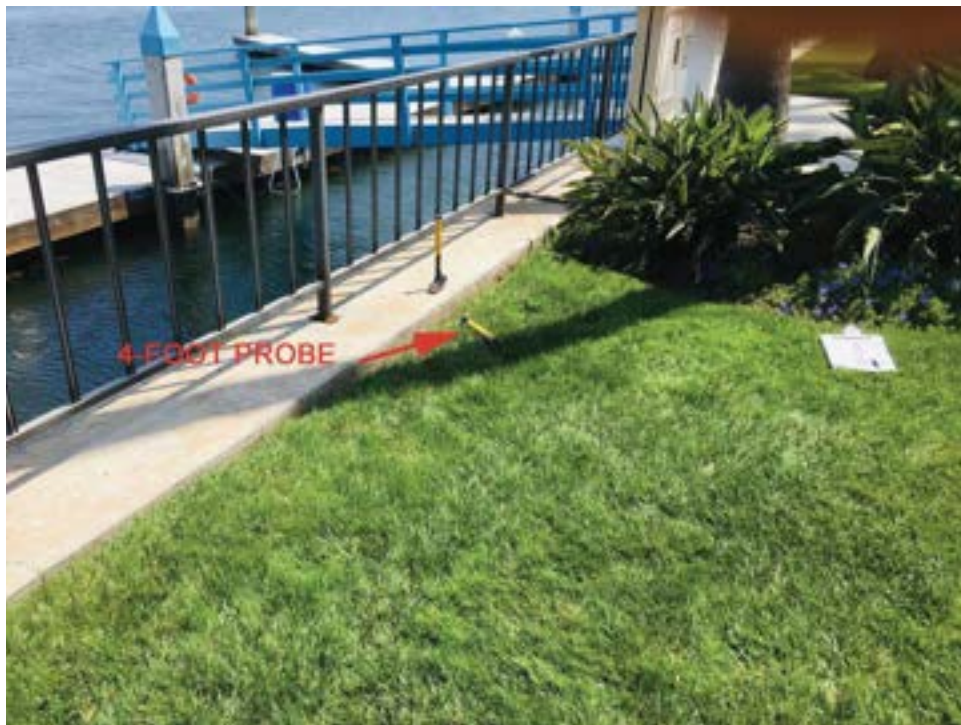
Photo 10: Antigua Court. Note grass area experiencing settlement.  
Also note handle of 4 foot probe, indicating loose soil behind bulkhead.

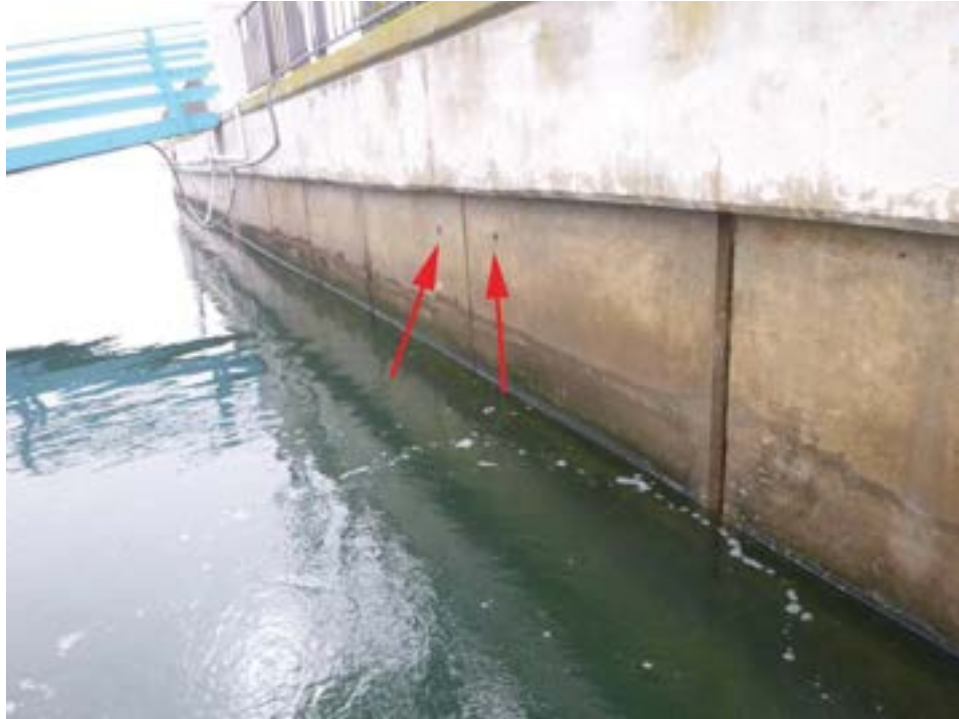
Photo 11: Antigua Court.

Note two penetrations (arrows) in bulkhead below area experiencing settlement.

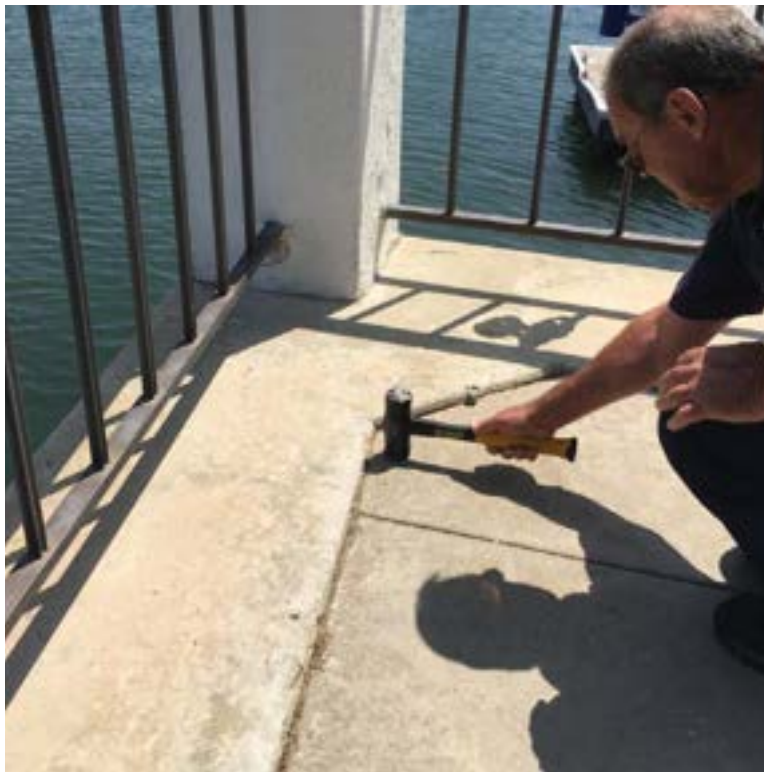
Photo 12: Antigua Court. Checking for voids under sidewalk at common area, northeast corner of Antigua Court.

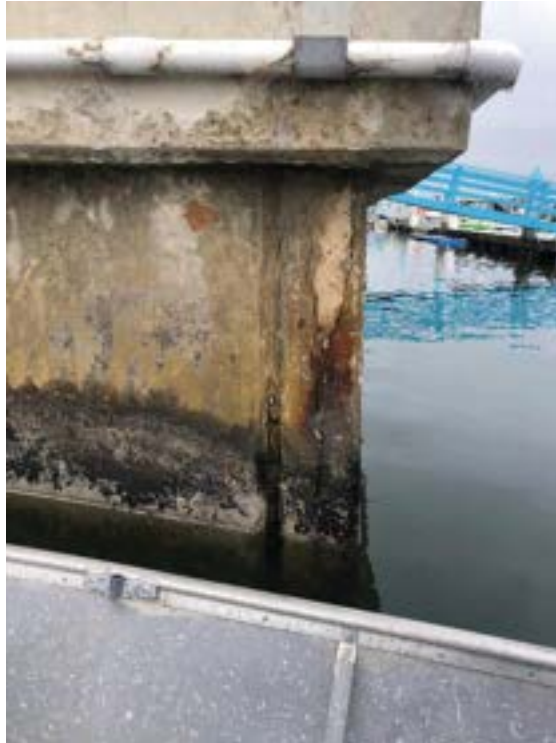
Photo 13: Antigua Court, northeast corner (north wall). Vertical cracks, rust, spalling, wide joint, talus observed.

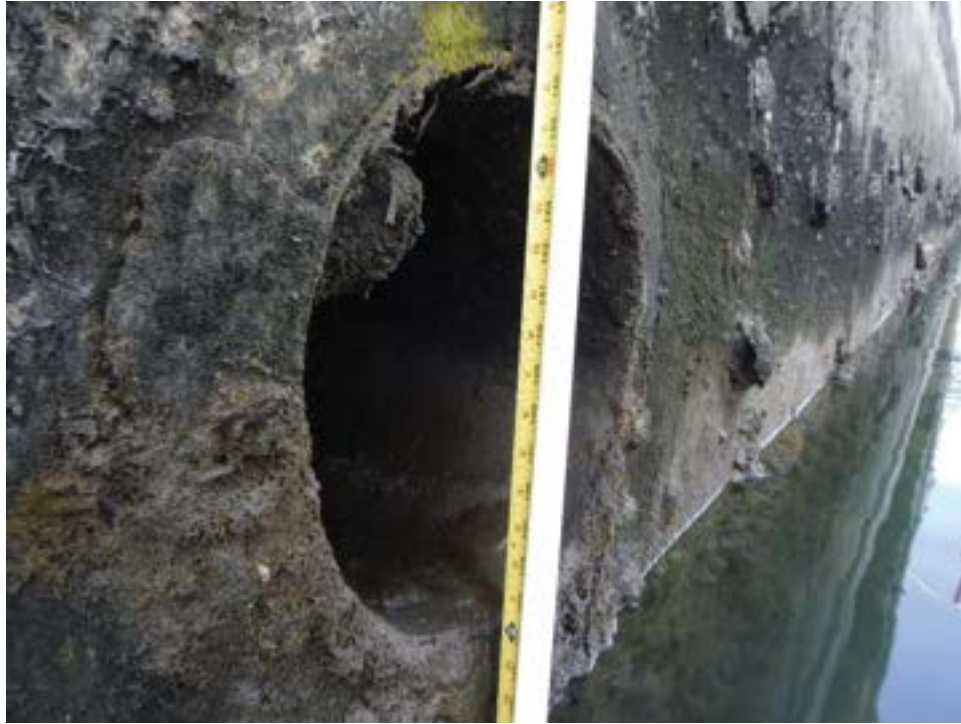
Photo 15: Antigua Court, South Side, Lot 19/21.  
14-inch storm drain under gangway at P/L.

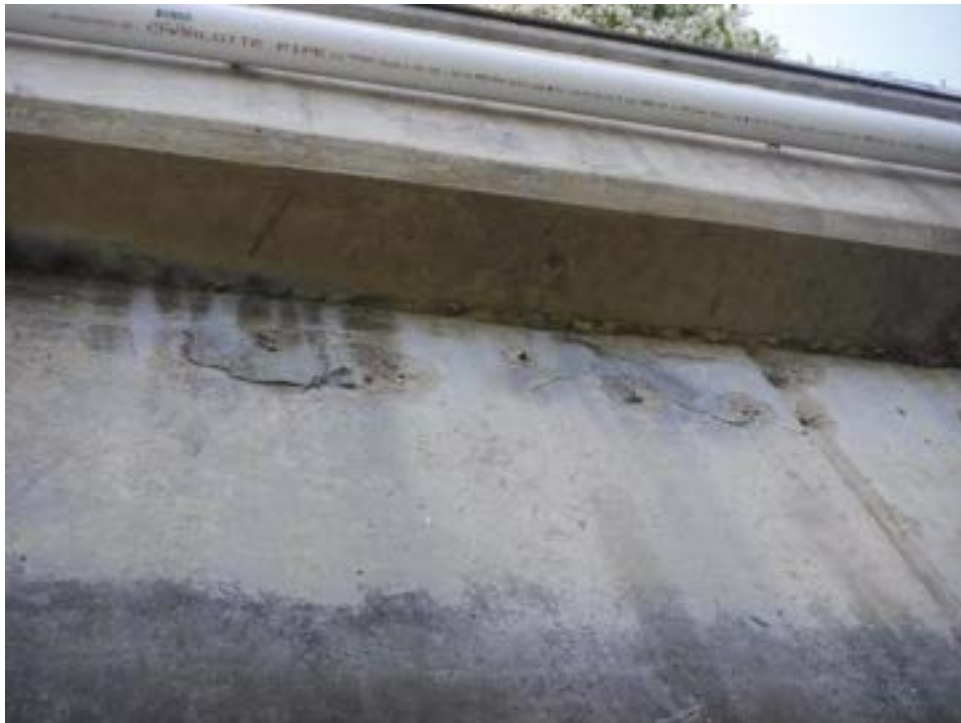
Photo 16: Antigua Court, Lot 11, 5 feet south of P/L.  
Spalling under pile cap.

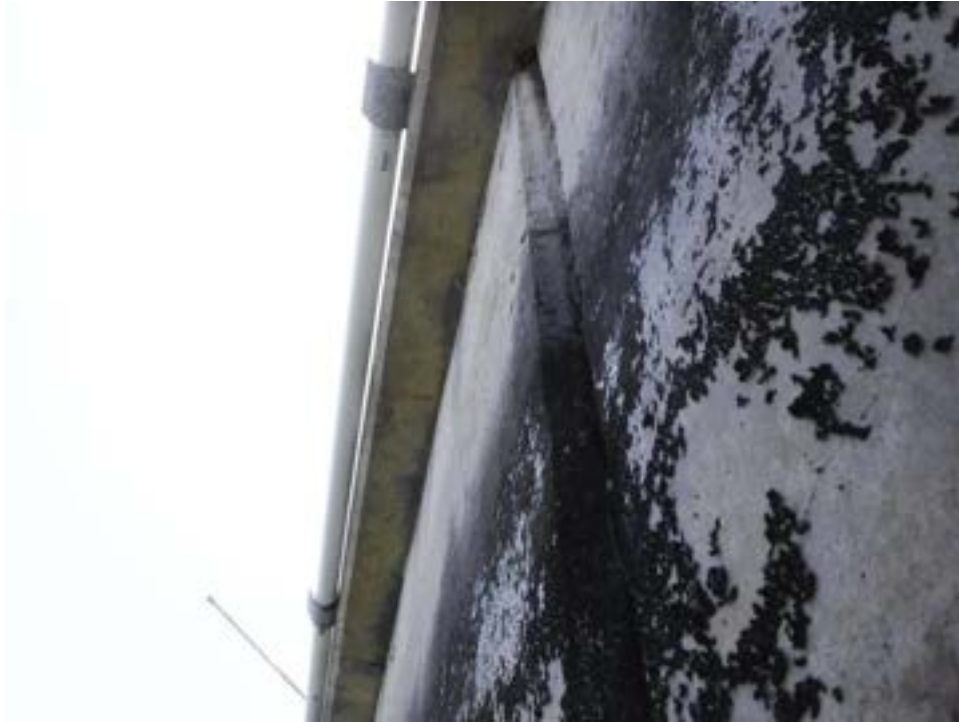
Photo 17: Antigua Court, Lot 5, 5 feet south of P/L.  
Panel joint is rotated approximately 0.75 inch at the top.

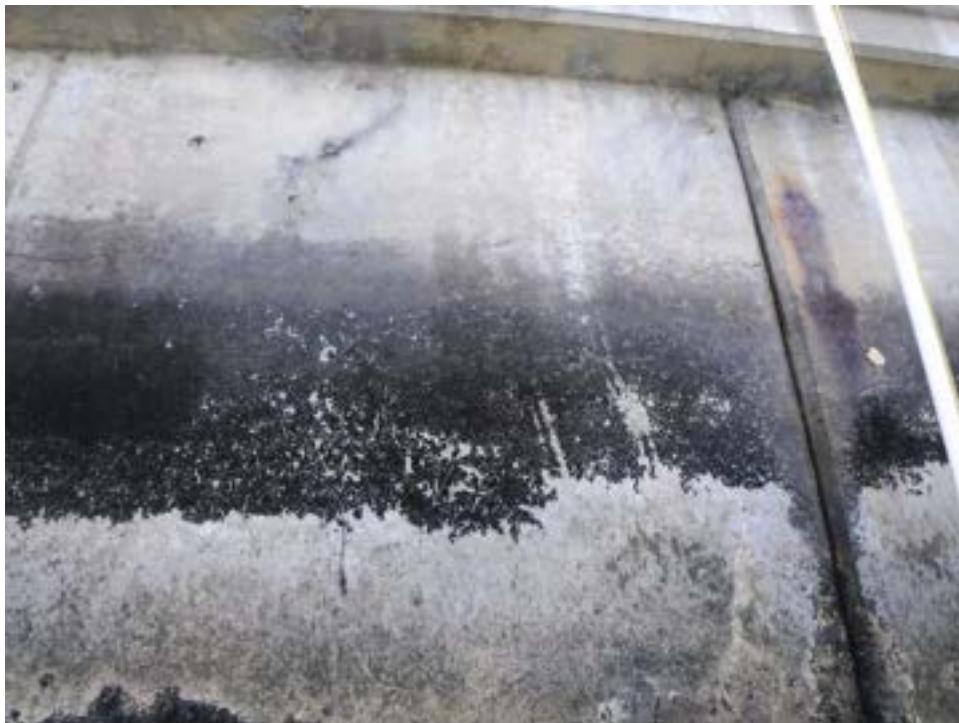
Photo 18: Antigua Court, Lot 3/5 P/L, north side of gangway.  
Panel joint widens to >2.5 inches at top of panel and tapers to >0.25 inch at waterline.  
Minor horizontal cracking approximately 2 to 3 feet below pile cap.

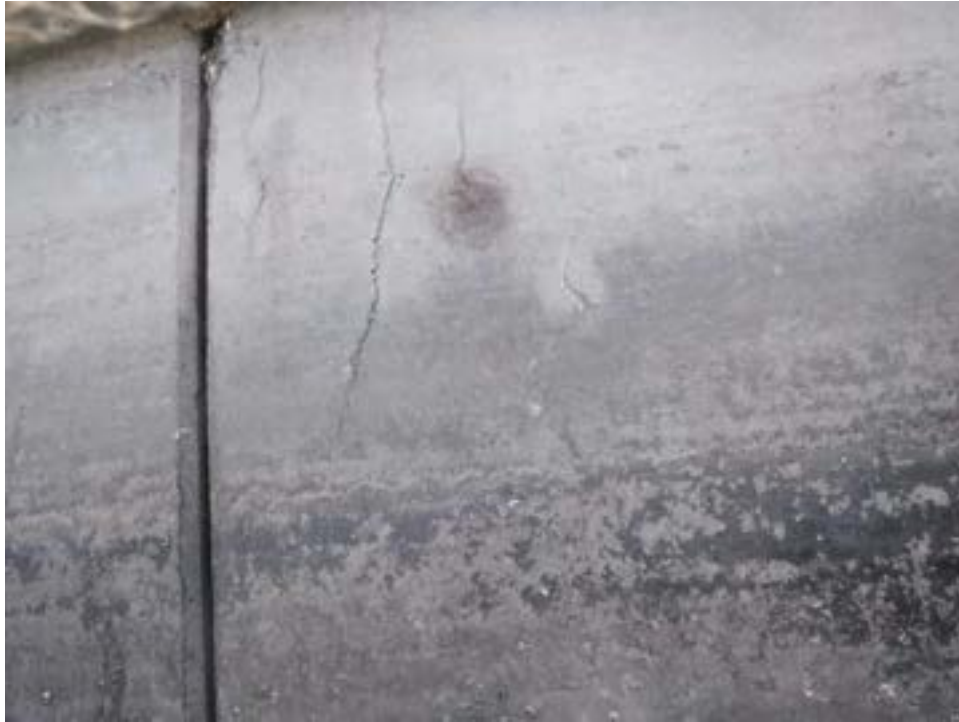
Photo 19: Antigua Court at Grand Caribe causeway.  
Vertical cracking, minor spalling on bulkhead panel.
