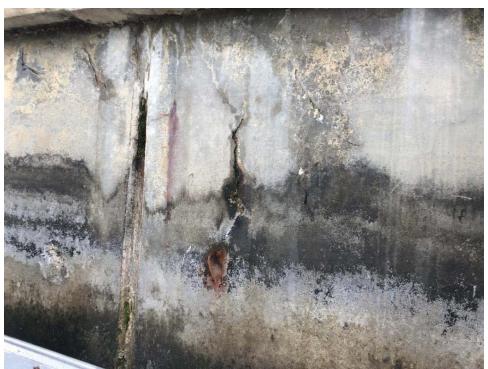
Photo 1: Kingston Court, Lots 3-13, 32 feet south of northern corner.

Vertical crack bleeding rust.

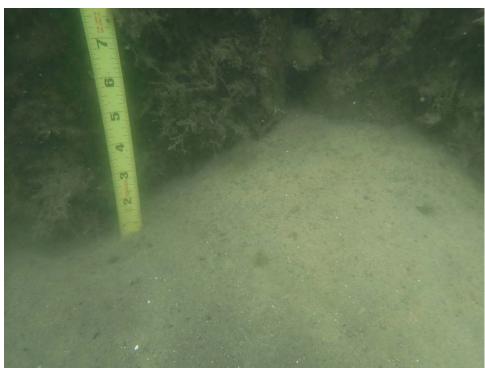
Photo 3: Kingston Court E, talus pile (9" w x 3" h) at 1-inch-wide joint south of Gangway 4.

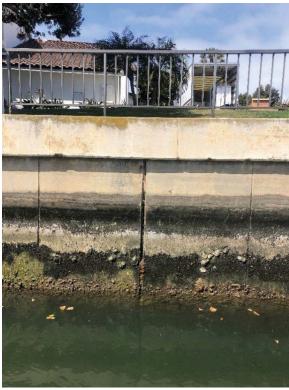
Photo 4: Kingston Court S (end of east cul-de-sac), panel under second gangway. Soil on top of grout (grout breach).

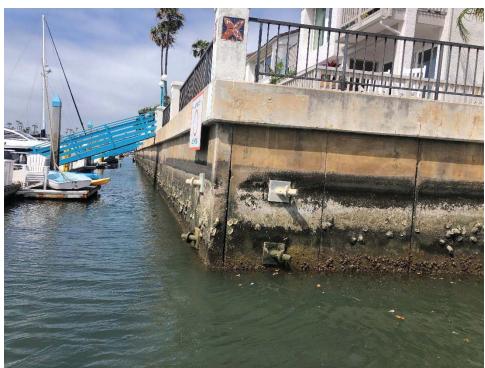
Photo 5: Kingston Court, panel under second gangway.
Two diagonal tie rods have been installed.

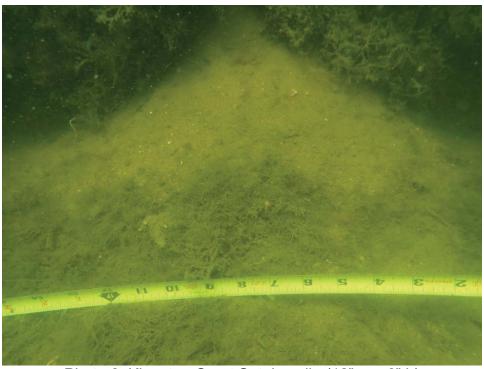
Photo 6: Kingston Court S, talus pile (12" w x 6" h) at 1-inch-wide joint west of Gangway 11.

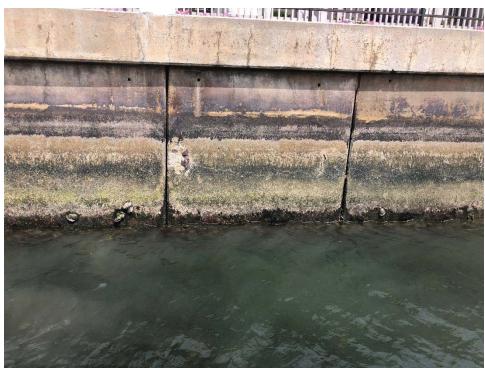
Photo 7: Kingston Court, fifth panel from west end (southern corner).

Significant cracking.

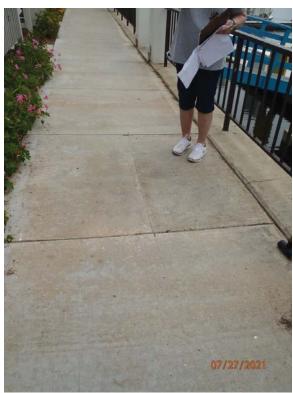
Photo 8: West of Gangway 16.
Void detected under concrete patch in sidewalk on southerly end of Kingston Court.

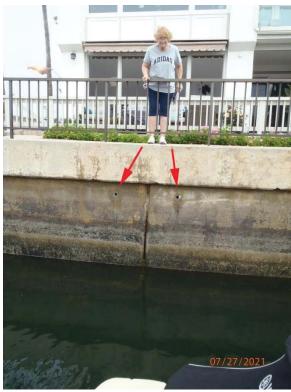
Photo 9: West of Gangway 16.

Note two bulkhead penetrations located below the concrete patch.

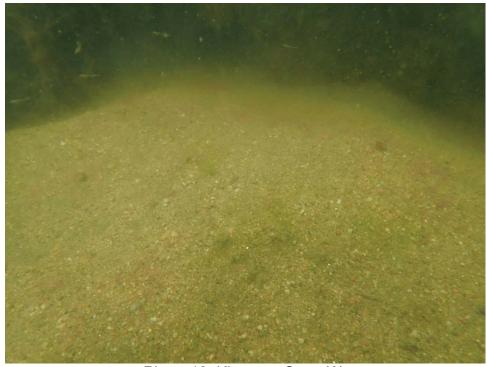
Photo 10: Kingston Court W. Small talus pile at 1.25-inch-wide joint 85 feet south of Gangway 17.

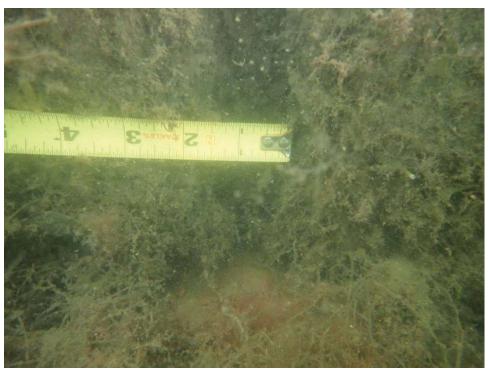
Photo 11: Kingston Court W.
Small talus pile covered by growth at 1.25-inch-wide joint north of Gangway 19.

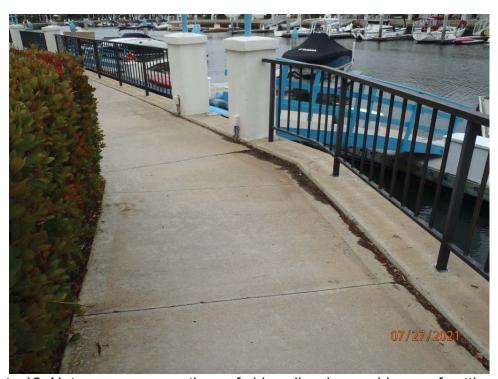
Photo 12: Note numerous sections of sidewalks show evidence of settlement adjacent to the bulkheads. Gangway 20 in background.

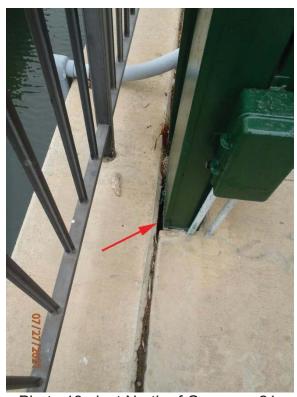
Photo 13: Just North of Gangway 21.

Many electrical panels have void spaces, allowing surface water to infiltrate between sidewalk and bulkhead.

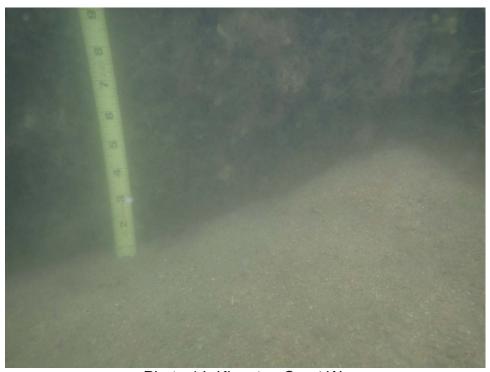
Photo 14: Kingston Court W.
Talus pile (12" w x 3" h) at 1-inch-wide joint south of Gangway 24.

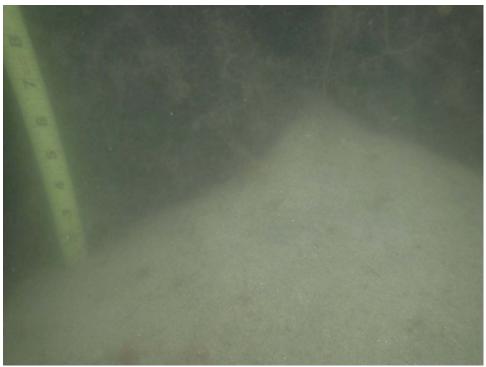
Photo 15: Kingston Court W.
Talus pile (12" w x 5" h) at 1-inch-wide joint south of Gangway 26.
