APPENDIX E

JAMAICA VILLAGE

CORONADO CAYS BULKHEADS

Project Number T2904.070.001

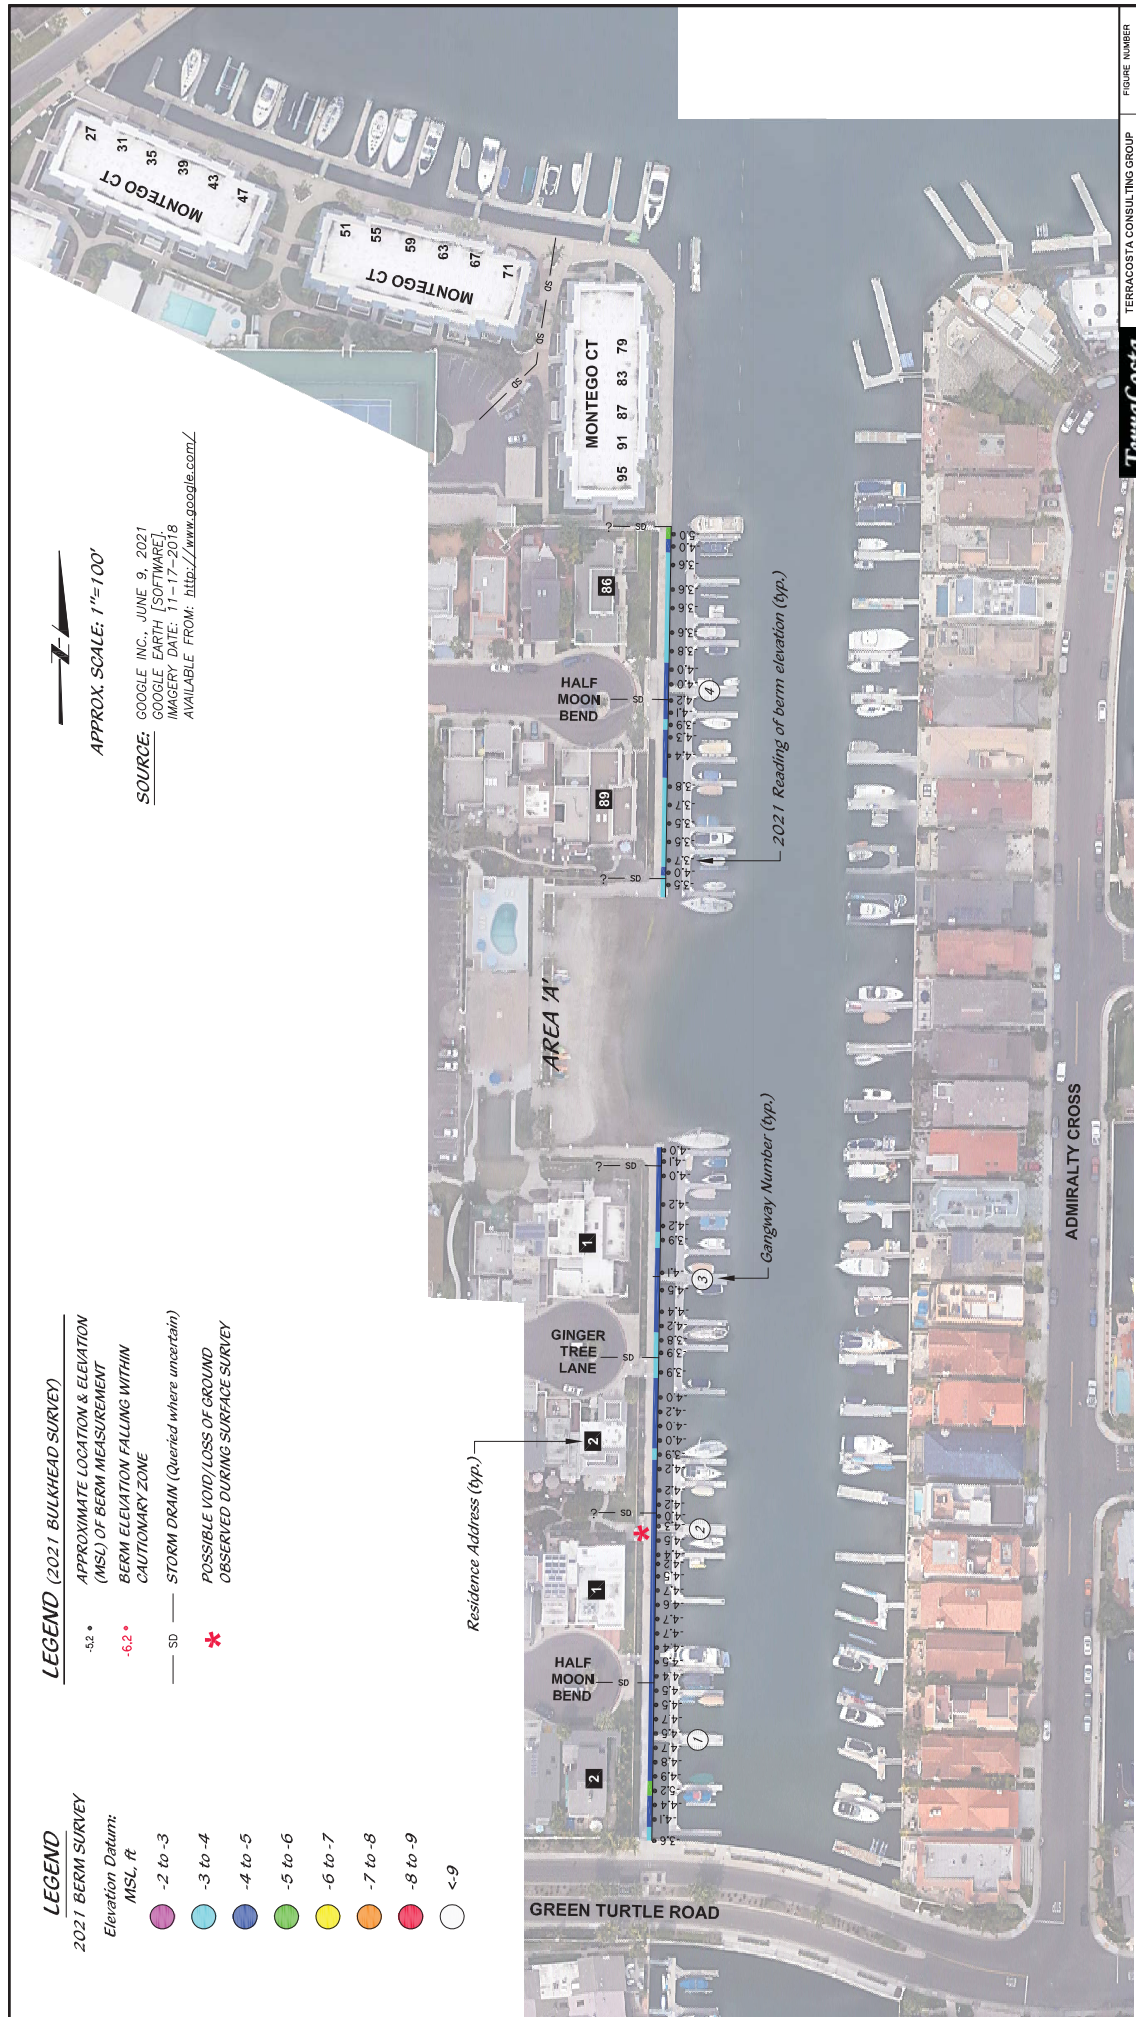
TERRACOSTA CONSULTING GROUP 3800 MURPHY CANYON ROAD, SUITE 200 SAN DIEGO, CA 92123 858.973.8900	FIGURE NUMBER E-1
CORONADO CAYS BULKHEADS	PROJECT NUMBER T2904.070.001

AREA	SHEET PILE LENGTH	CAUTIONARY	SERIOUS
A	17.5 FT. (including Cap)	-6 TO -7 MSL	< -7 MSL

Elevation of top of Pile Cap: 7.1' MSL
If present, elevation of architectural cap varies.

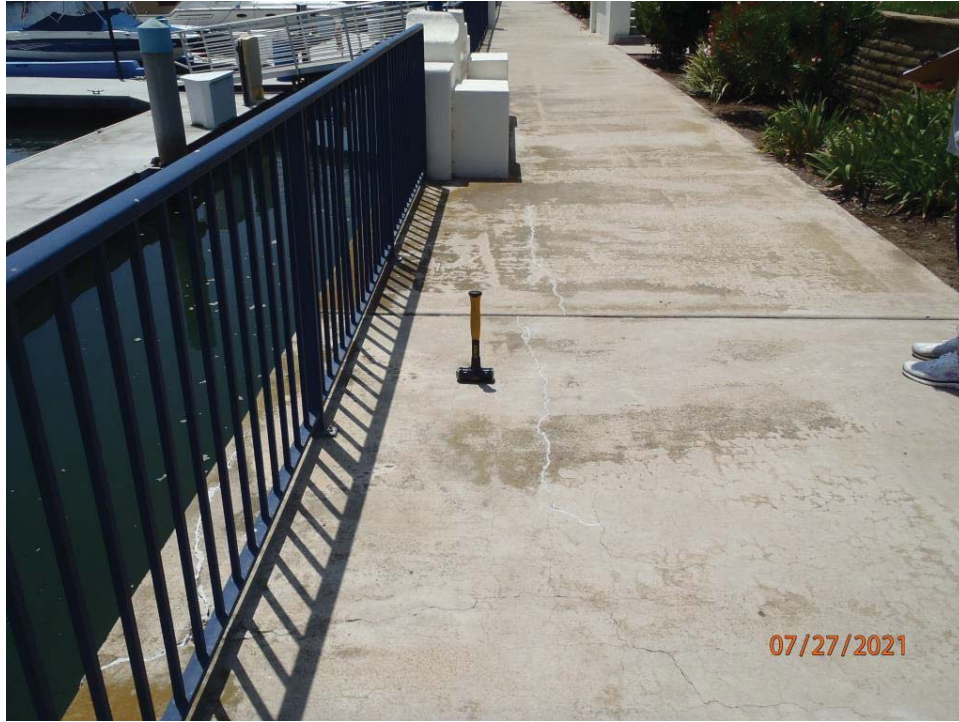
Photo 1 – Sidewalk at southeast corner of Jamaica Village midway between Half Moon Bend and Ginger Tree Lane shows evidence of settlement and voids.
