**APPENDIX F**  
**Bahama Village**

Field Survey Dates: May 18, 19, & 20, and June 25, 2021

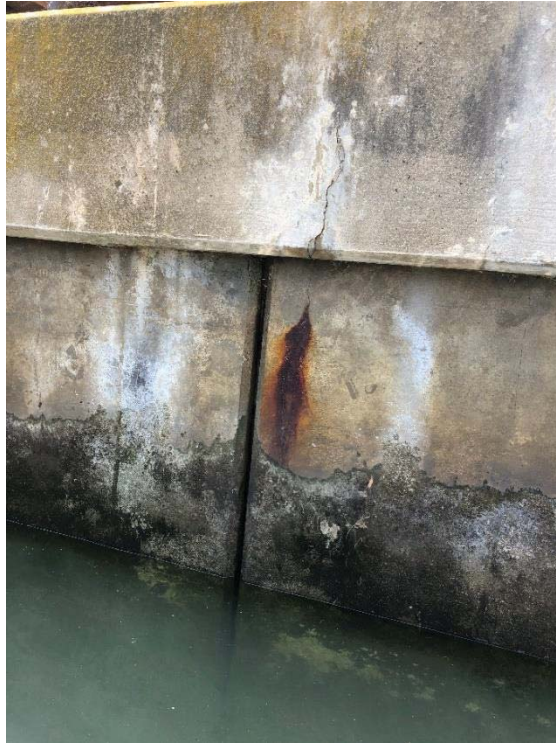
Photo 1: Catspaw Cape, first panel south of Lot 87 gangway.  
Rust bleeding.

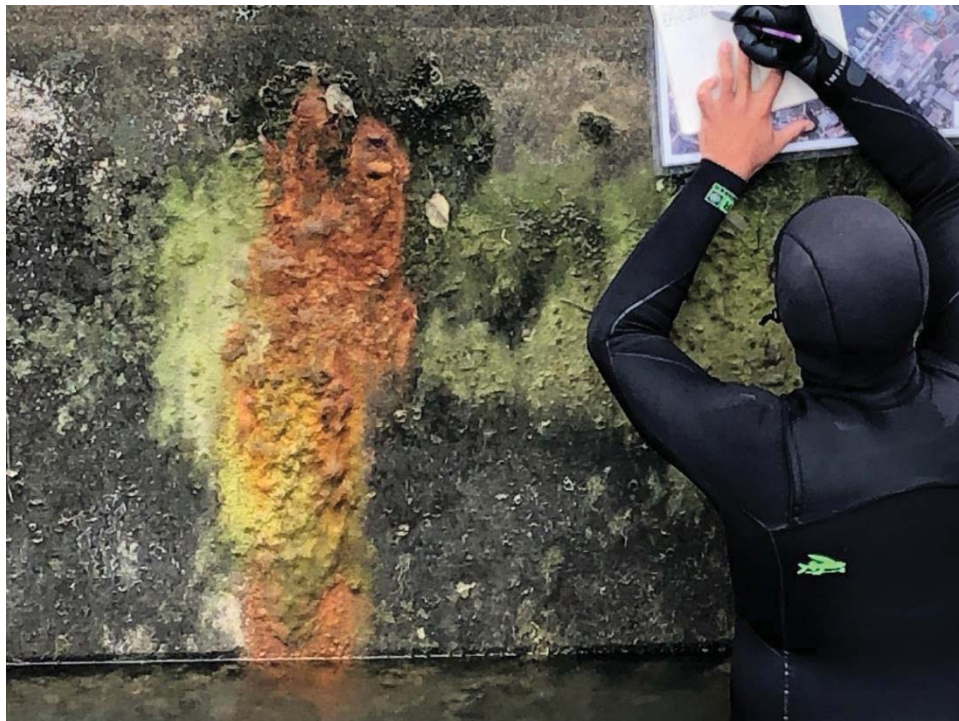
Photo 2: Catspaw Cape, first panel south of Lot 63 gangway.  
Badly rust bleeding.

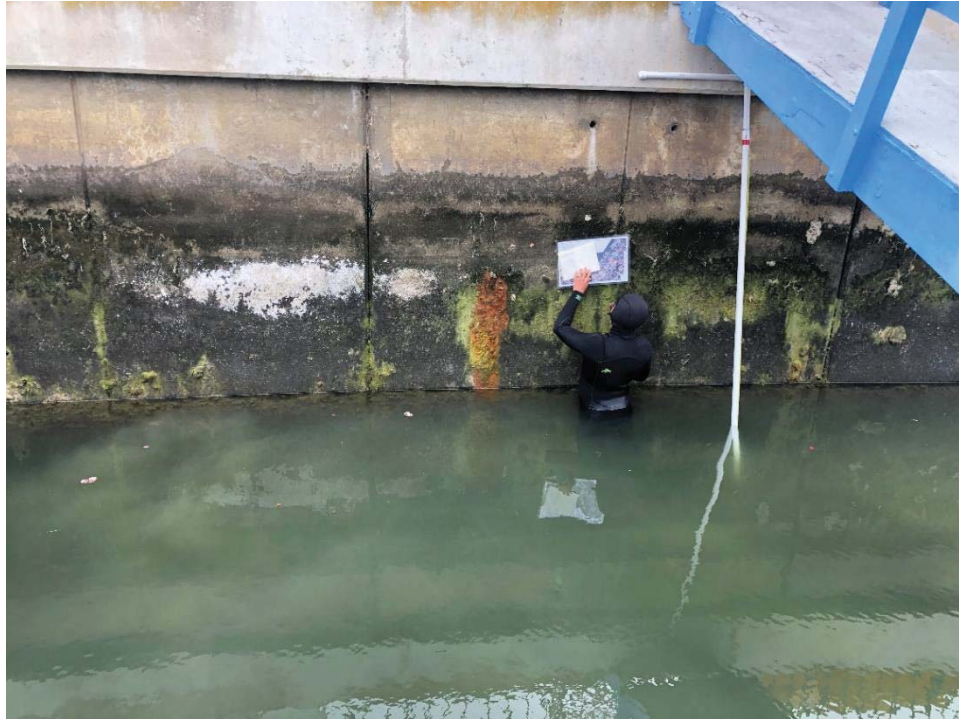
Photo 3: Catspaw Cape, west of Lot 55, public gangway.  
Rust stains east and west of gangway.

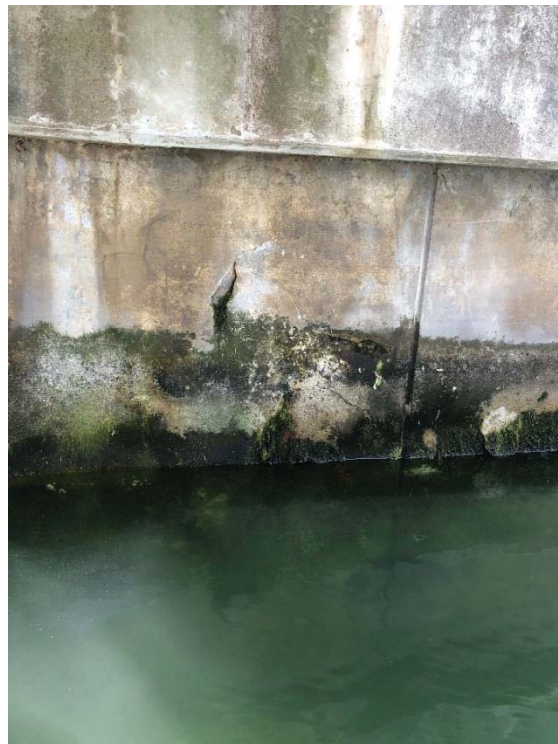
Photo 4: Catspaw Cape, Lot 53 gangway.  
Deep spall.

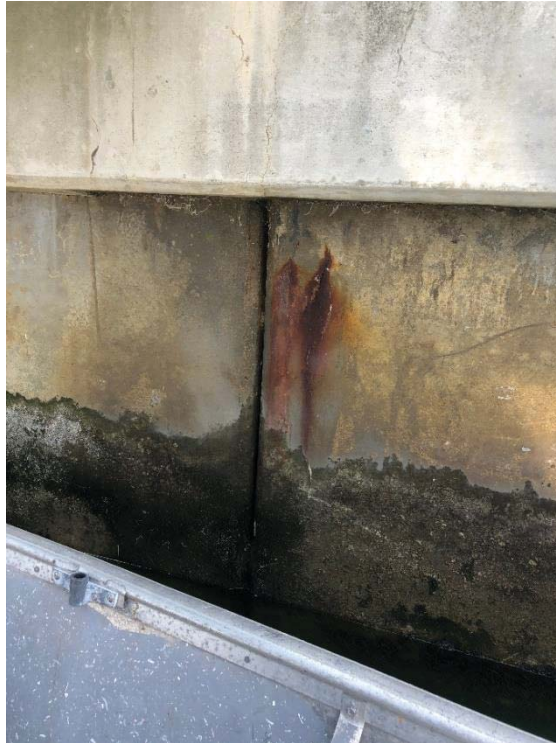
Photo 5: Catspaw Cape, Lot 49.  
Crack with rust stains right of joint.

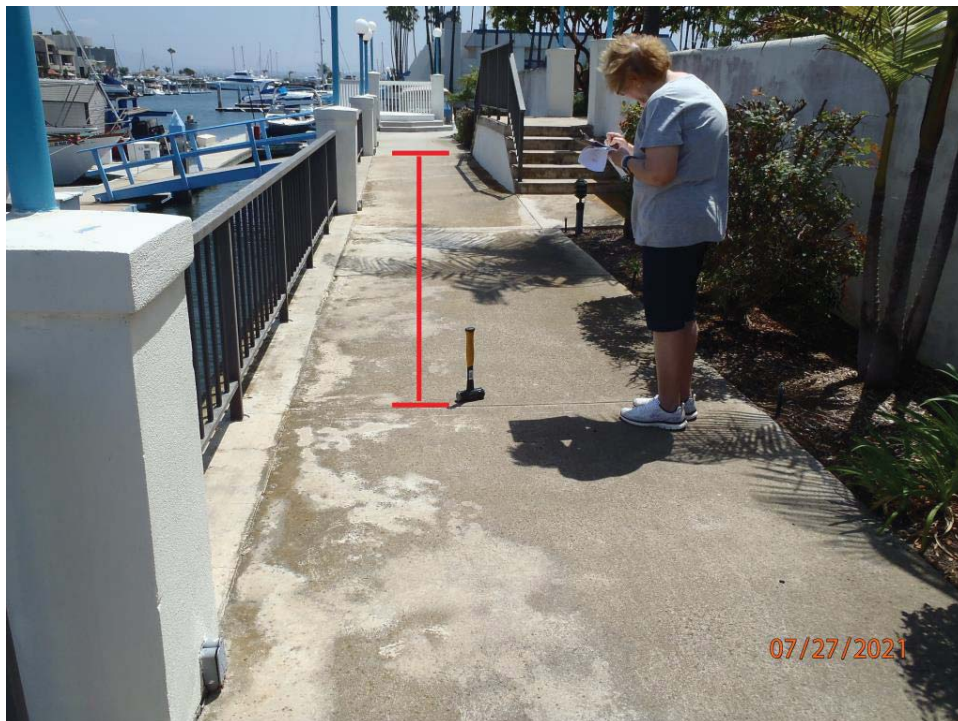
Photo 6: Voids detected under sidewalk from east side of stairs to approx.. 20 feet west of stairs. Also randomly detected voids adjacent to the bulkhead in other locations along the north bulkhead.

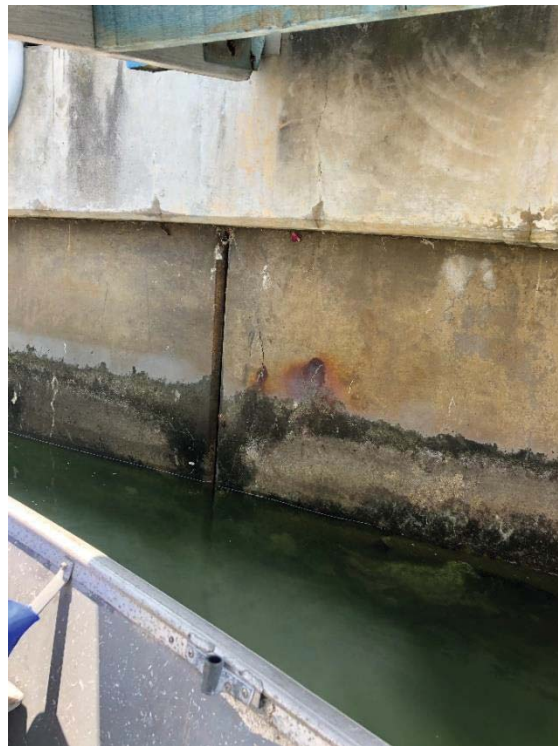
Photo 8: Catspaw Cape, CCHOA west of gangway.  
Under gangway, vertical crack and rust.

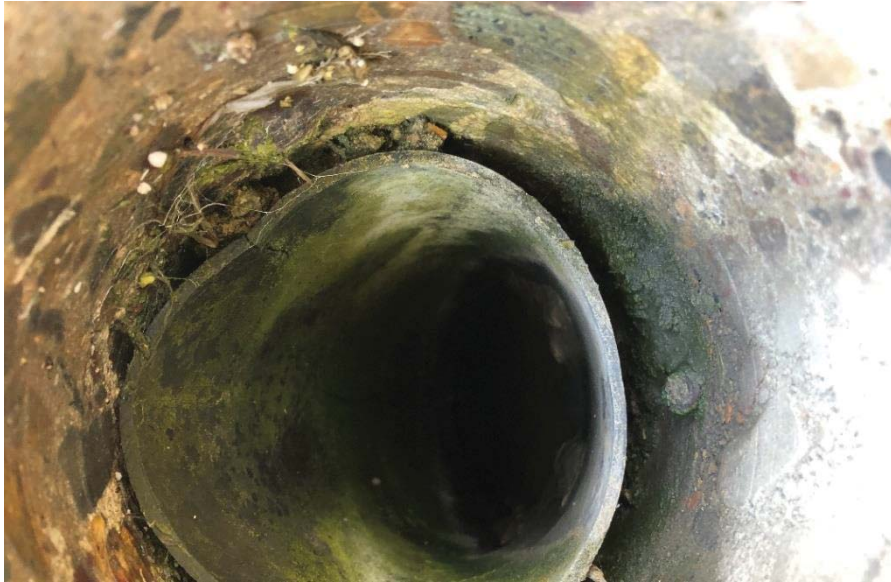
Photo 9: Catspaw Cape, second panel south of gangway.  
5-inch cored hole; inside PVC pipe is crinkled.

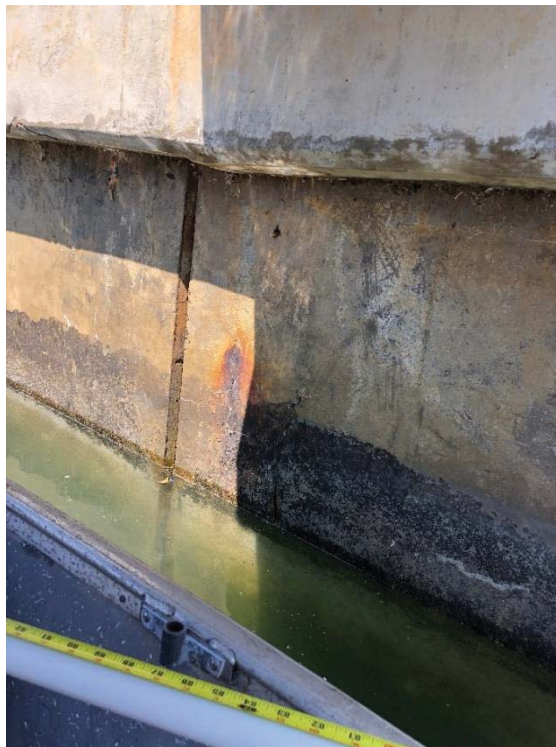
Photo 10: Catspaw Cape, Gangway between Lots 13 and 15.  
Rust and minor vertical cracking.

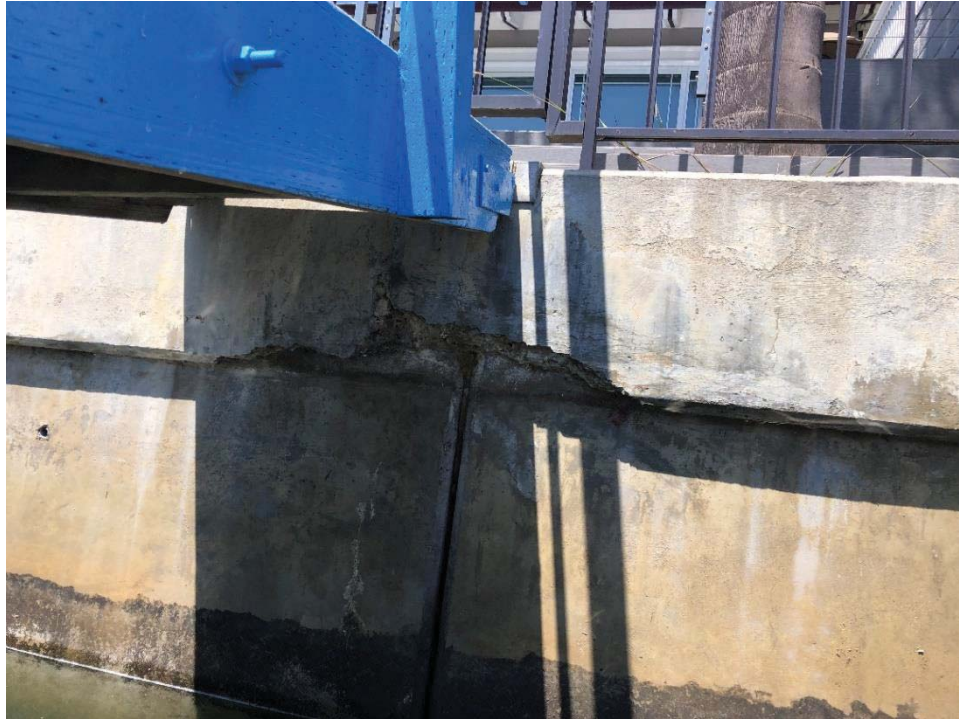
Photo 11: Catspaw Cape, Lot 13 gangway.  
Pile cap broken off, spalling; 1-inch opening at joint, no talus.

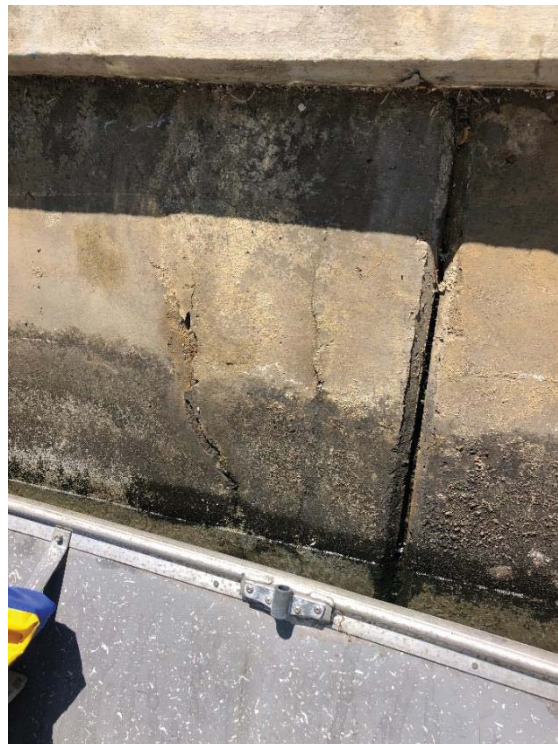
Photo 12: Catspaw Cape, third panel south of gangway.  
Vertical cracks.

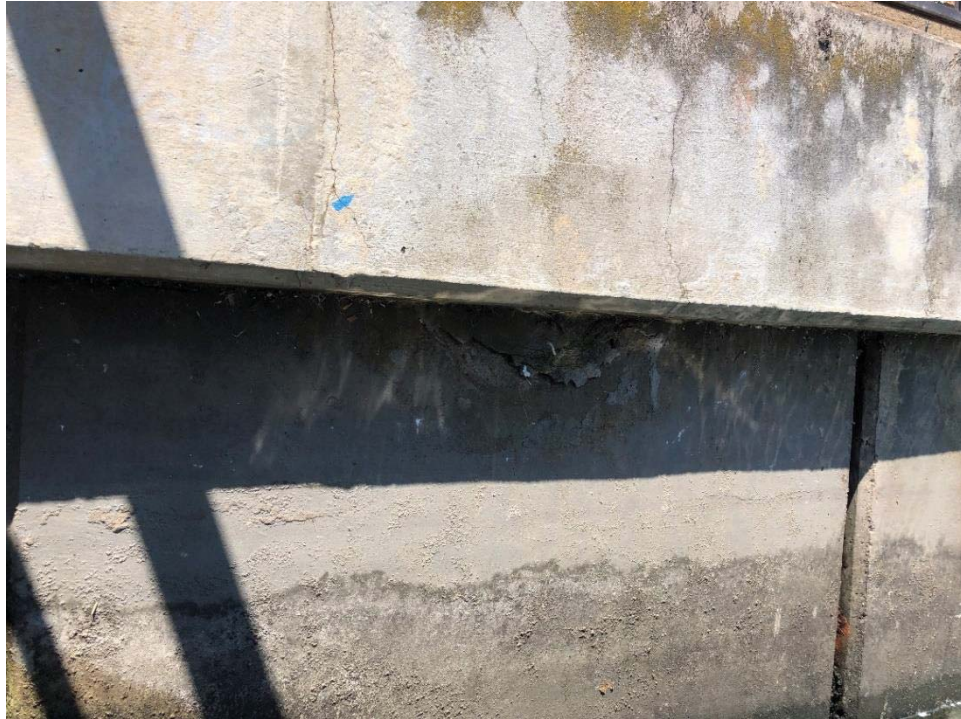
Photo 13: Catspaw Cape.  
Delamination and cracks, spalling under pile cap.

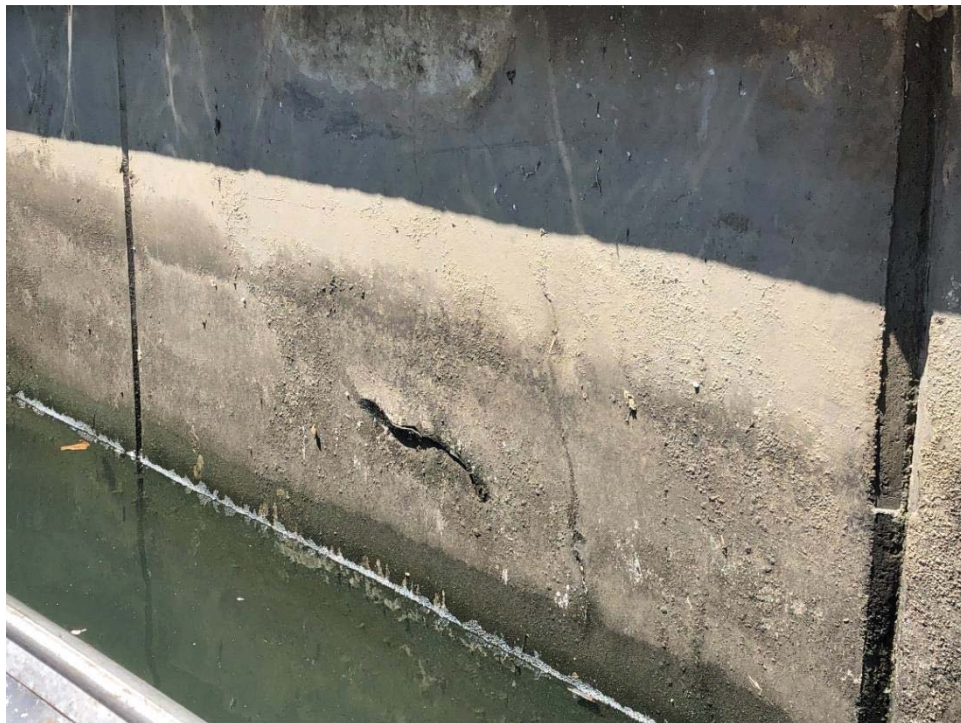
Photo 14: Catspaw Cape, Lot 1, north of gangway.  
Cracking and spalling.
