## **APPENDIX G**

### **Trinidad Village**

**CORONADO CAYS BULKHEADS**  
**Port of Spain (Trinidad Village)**  
**Project Number T2904.070.001**

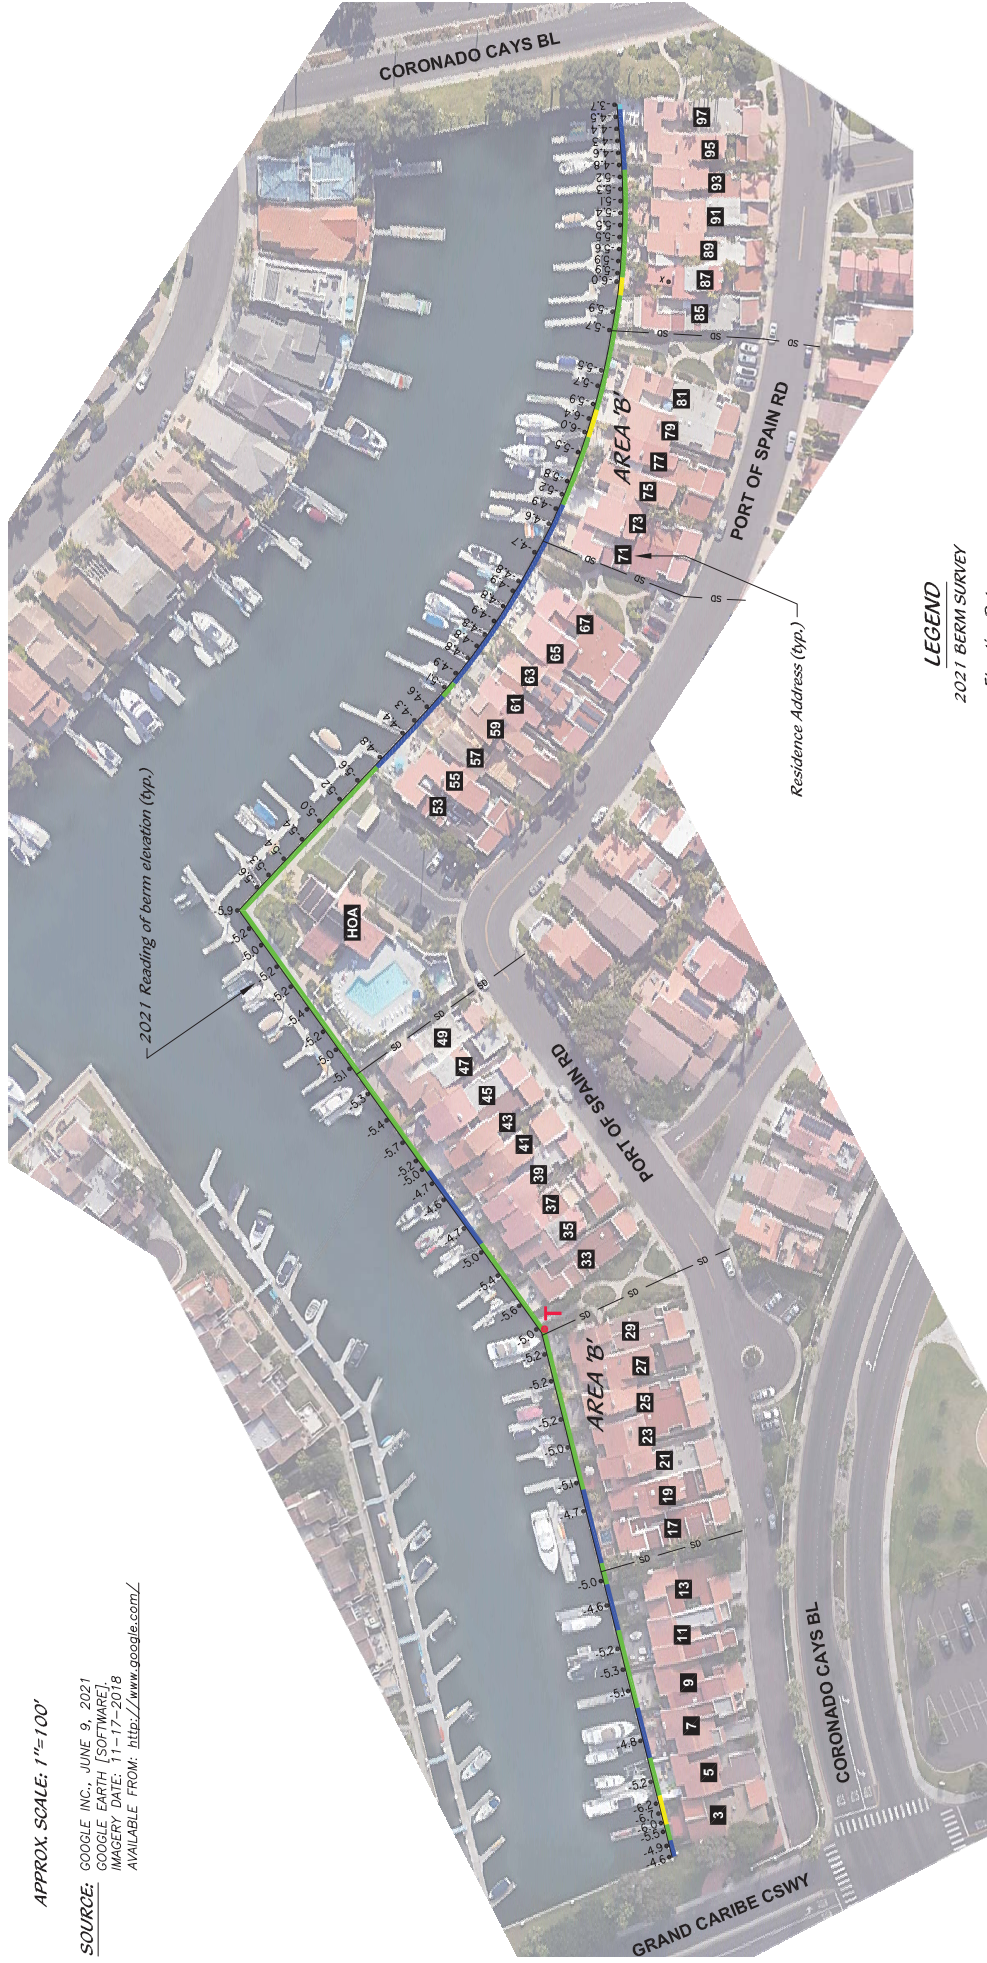
TERRACOSTA CONSULTING GROUP 3885 MURPHY CANYON ROAD, SUITE 200 SAN DIEGO, CA 92131 (858) 973-8800	FIGURE NUMBER <b>G-1</b>
PROJECT NAME CORONADO CAYS BULKHEADS	PROJECT NUMBER T2904.070.001

- 8.2 • APPROXIMATE LOCATION & ELEVATION (MSL) OF BERM MEASUREMENT
- 7.2 • BERM ELEVATION FALLING WITHIN CAUTIONARY ZONE
- SD — STORM DRAIN
- T TALLS OBSERVED AT PANEL JOINT DURING UNDERWATER INSPECTION

AREA	SHEET PILE LENGTH	CAUTIONARY	SERIOUS
B	20.0 FT (including Cap)	-7 TO -8 MSL	< -8 MSL

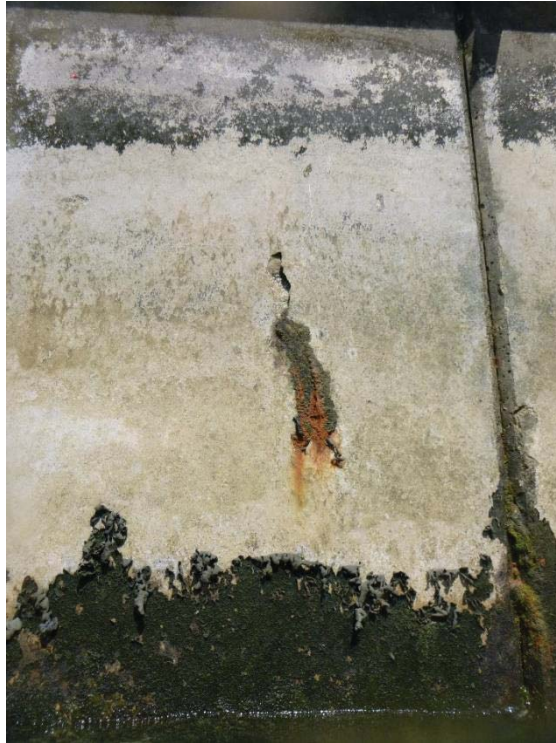
Photo 1: Port of Spain, One Panel North of Lot 77 Gangway.  
Rust and major cracking.

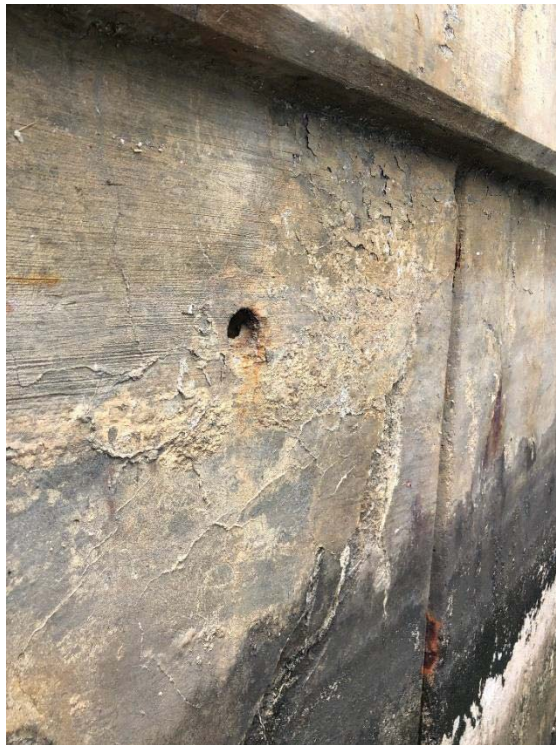
Photo 2: Port of Spain, 12 Panels north of Lot 53 Gangway.  
Spalling at panel joint.

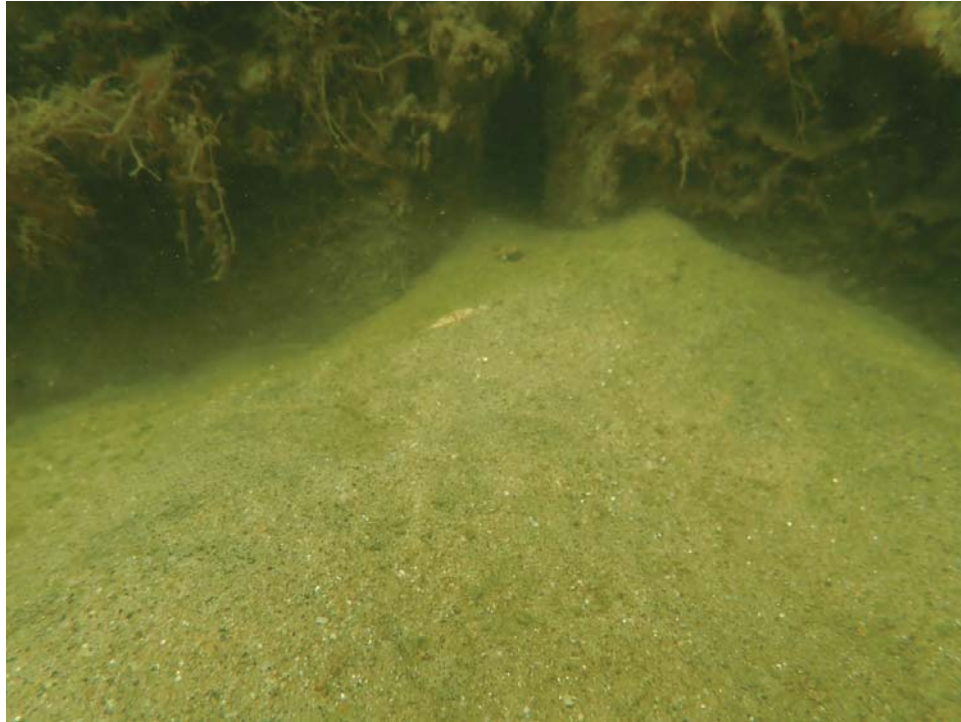
Photo 3: Port of Spain, 7<sup>th</sup> Panel North of Lot 29/31 Property Line.  
1-inch joint with 6" w x 3" h talus pile.

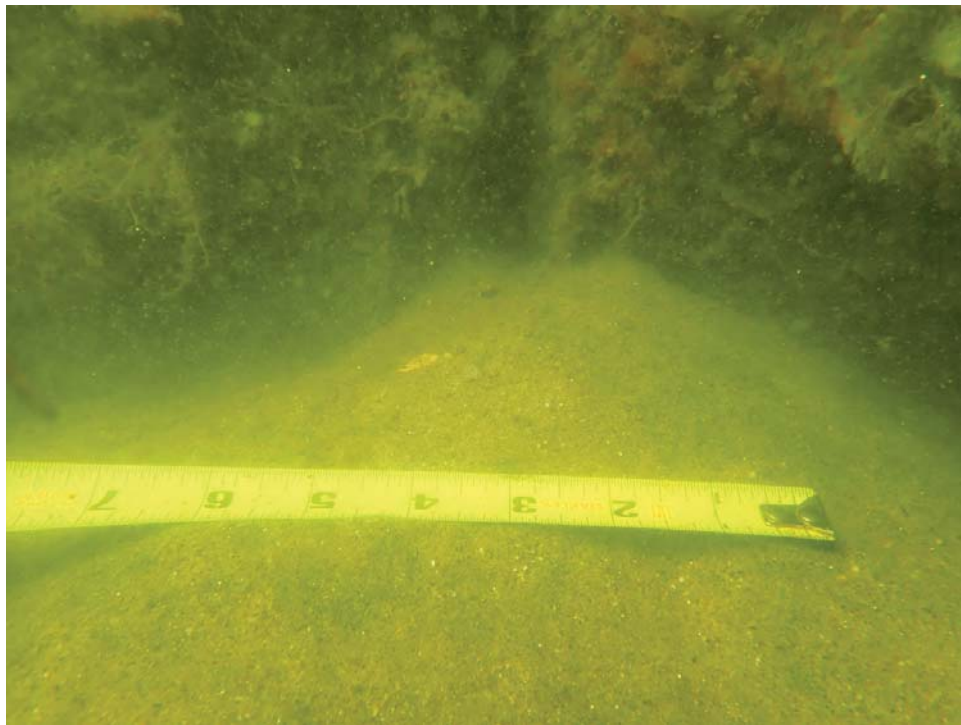
Photo 4: Port of Spain, 7<sup>th</sup> Panel North of Lot 29/31 Property Line.  
1-inch joint with 6" w x 3" h talus pile.

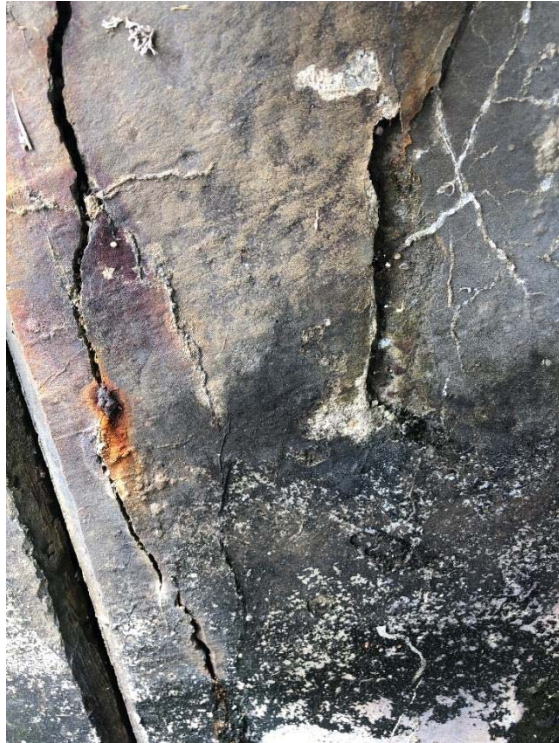
Photo 5: Port of Spain, Lot 3.  
Panels are badly cracked.

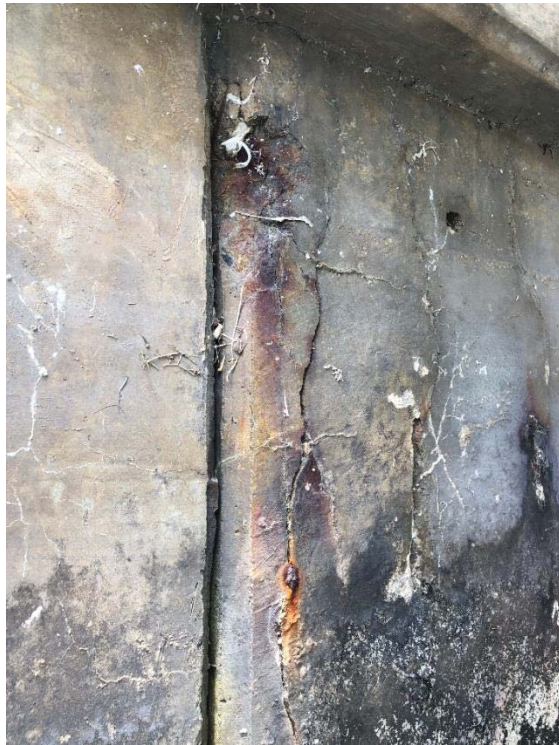
Photo 6: Port of Spain, Lot 3.  
Panels are badly cracked.

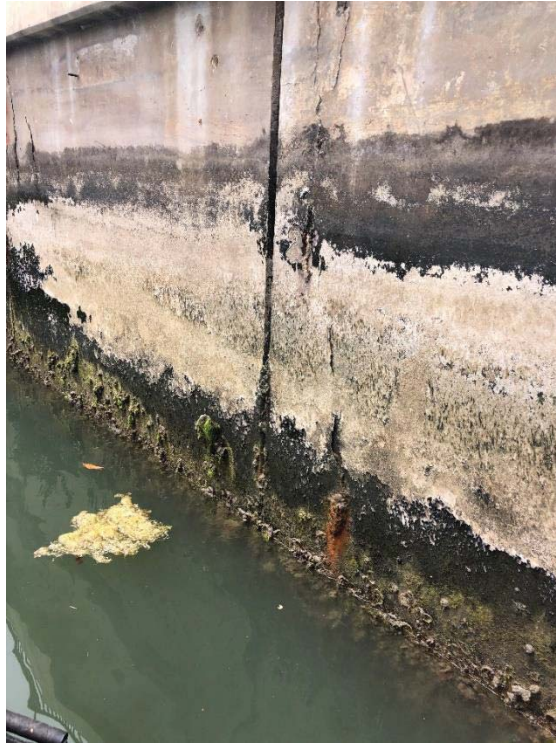
Photo 7: Port of Spain, Lot 3.  
Panels are badly cracked.

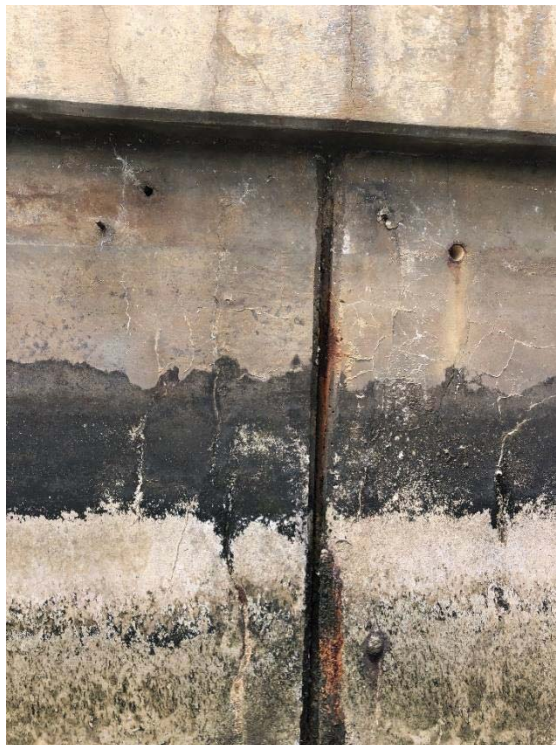
Photo 8: Port of Spain, Lot 3.  
Panels are badly cracked.

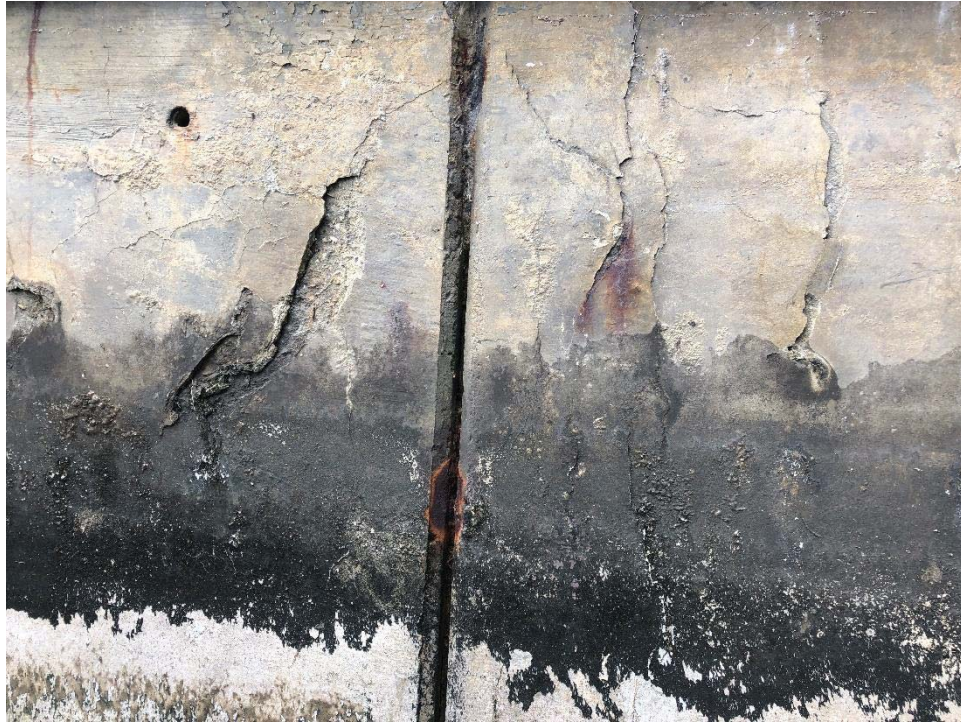
Photo 9: Port of Spain, Lot 3.  
Panels are badly cracked.

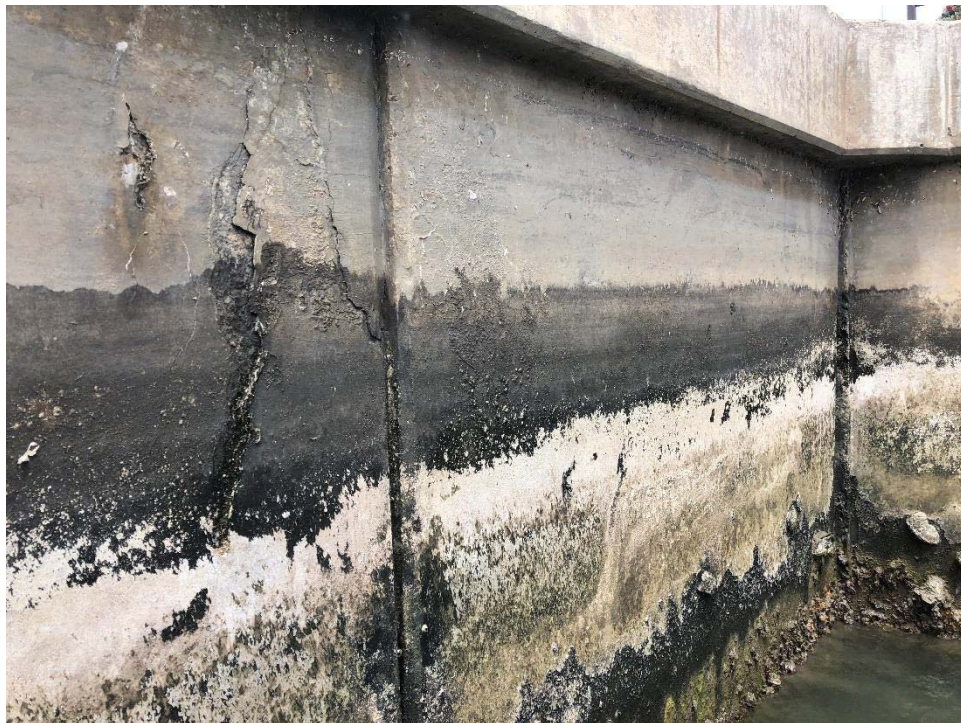
Photo 10: Port of Spain, Lot 3.  
Panels are badly cracked.

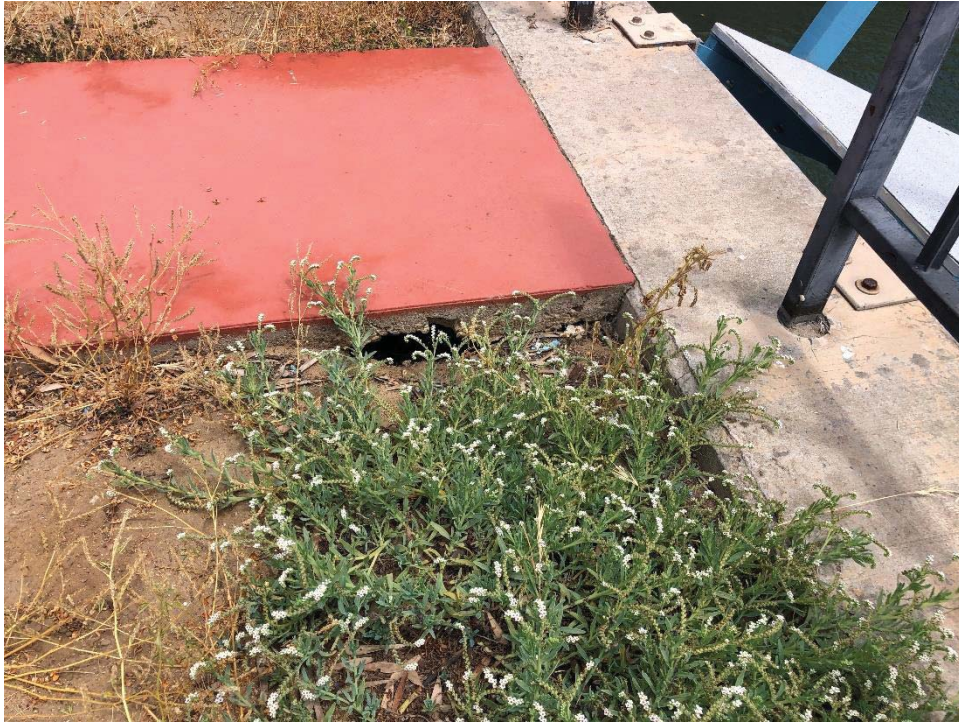
Photo 11: Port of Spain, Lot 3.  
Void under walkway suggests some lost ground.

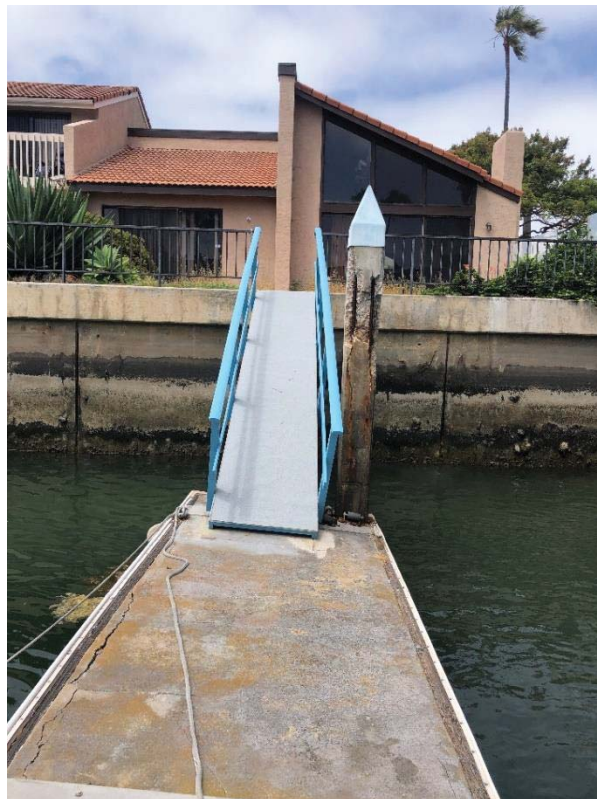
Photo 12: Port of Spain, Lot 3.  
No obvious rotation of panels.

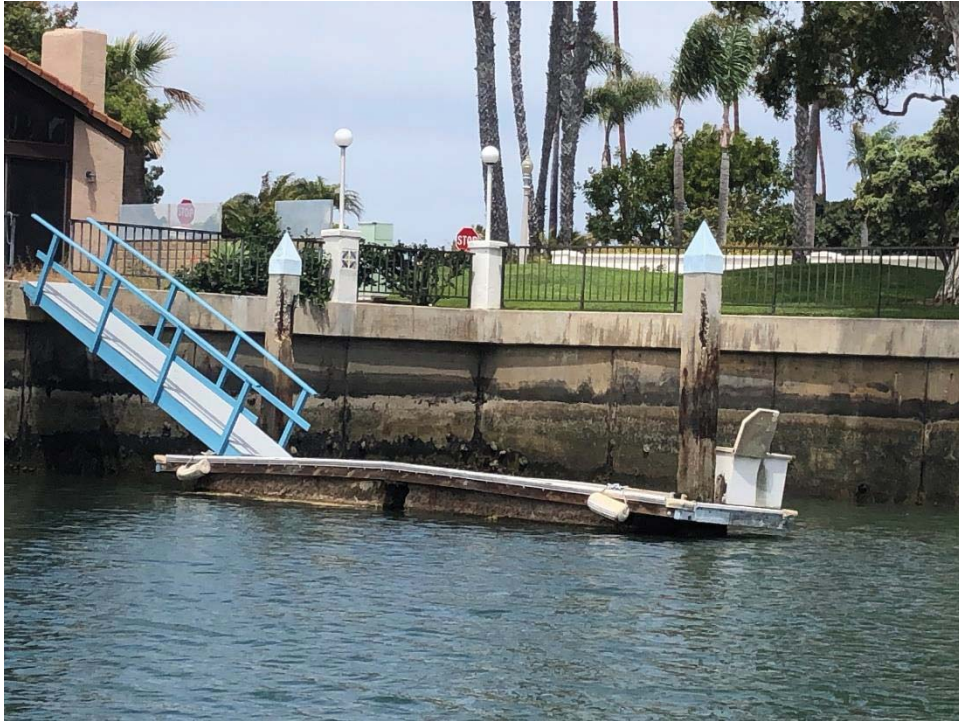
Photo 13: Port of Spain, Lot 3.  
No obvious rotation of panels.

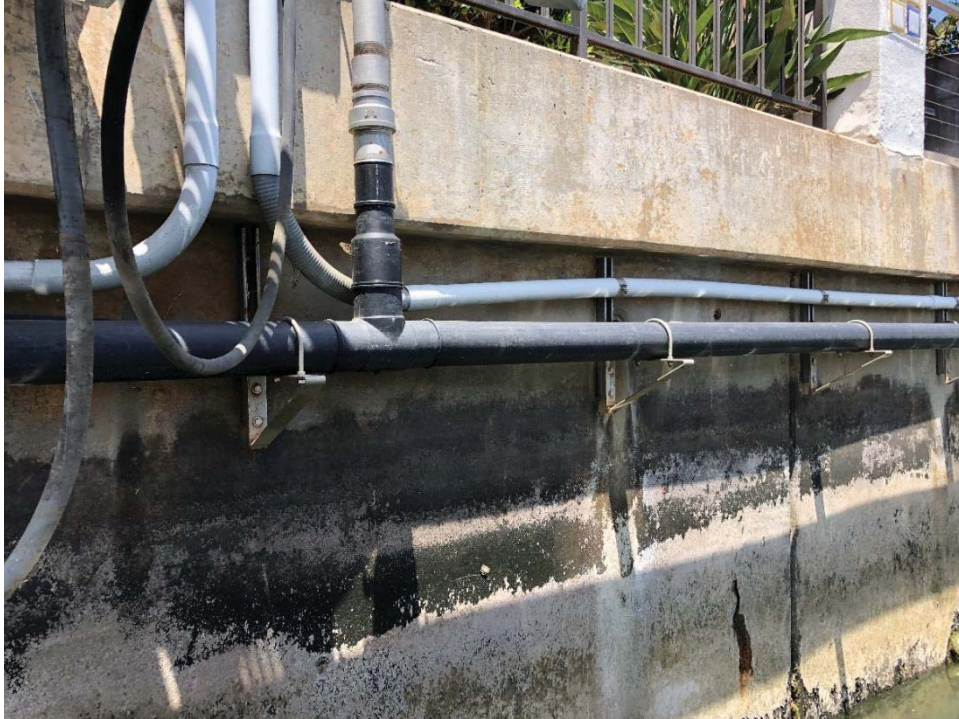
Photo 14: Port of Spain.  
This bulkhead has unusual utilities attached right under the pile cap.
