APPENDIX H

Blue Anchor Cay

CORONADO CAYS BULKHEADS

Project Number T2904.070.001

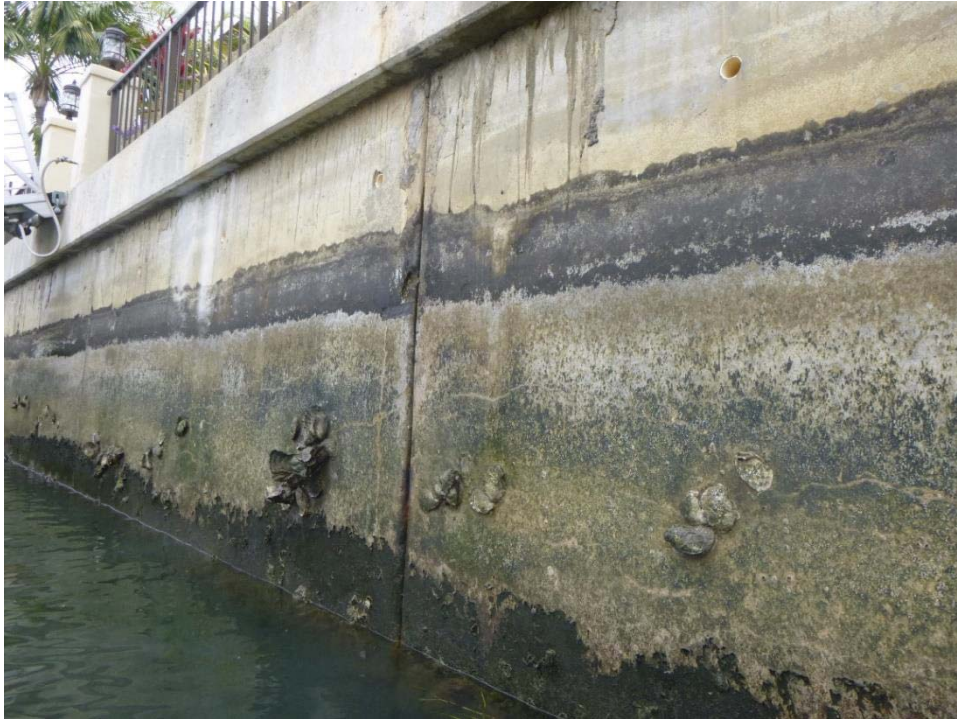
Photo 1: Blue Anchor Cay, Lot 36, Panel 3.
Horizontal cracks, spalling between Lots 36 and 34.

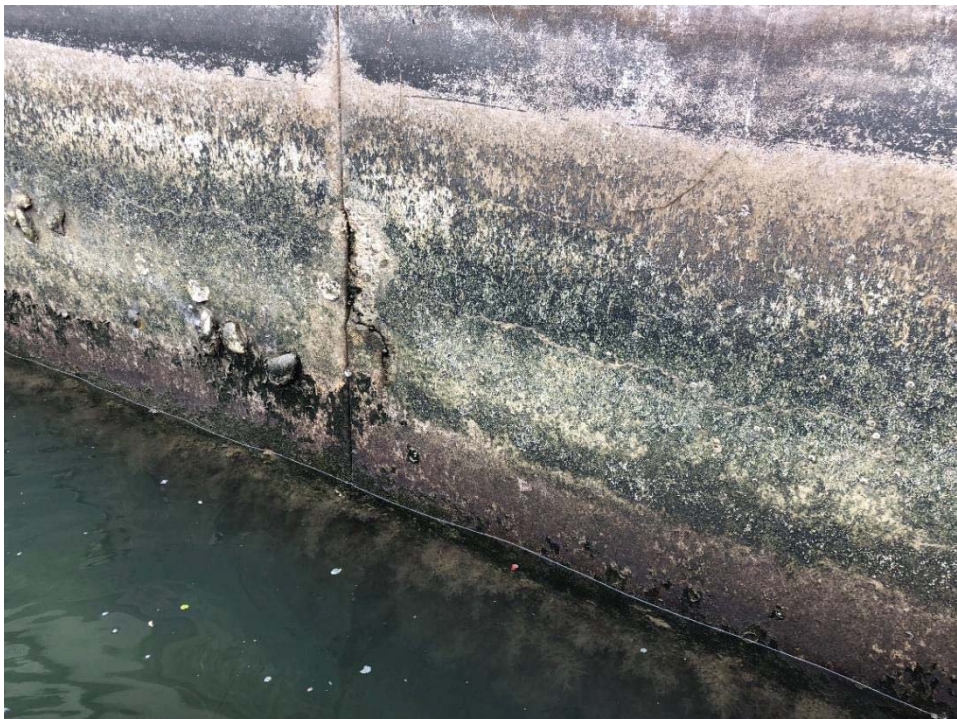
Photo 2: Blue Anchor Cay, Lot 30, west edge of west panel.
Cracking and spalling.

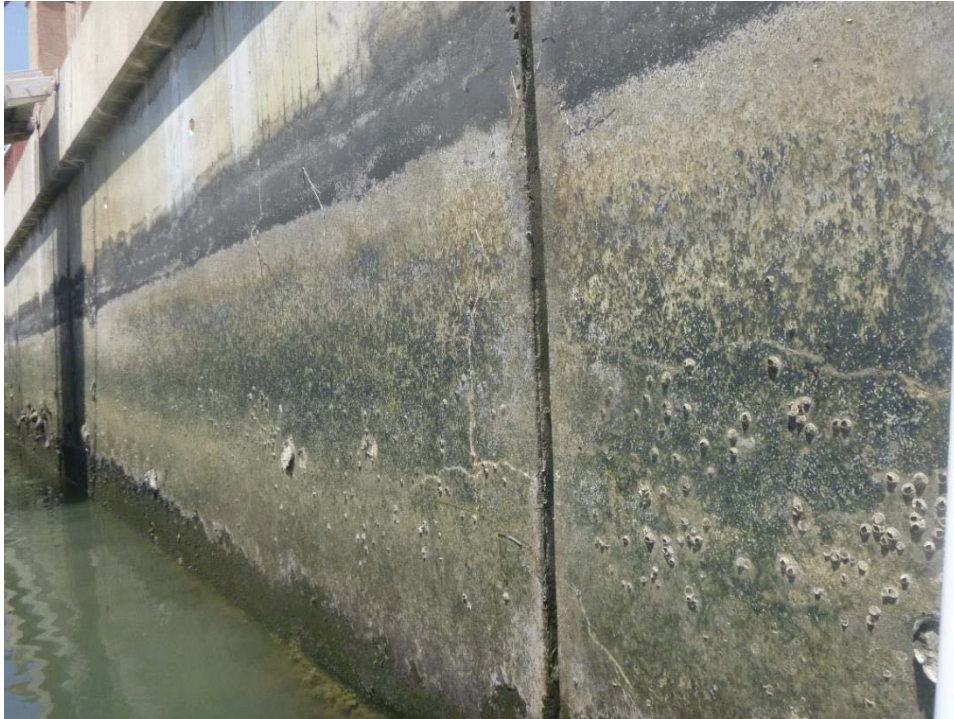
Photo 3: Blue Anchor Cay, Lot 28, Panel 2.
Separation between panels.

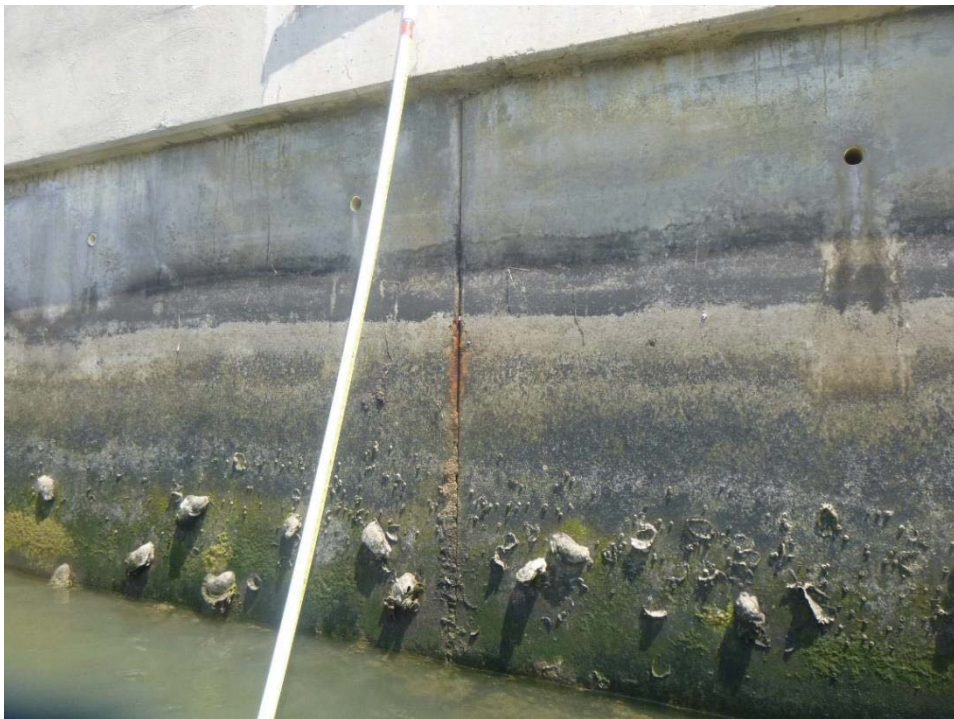
Photo 4: Blue Anchor Cay, Lot 8 Panel 1.
Rust at joint.

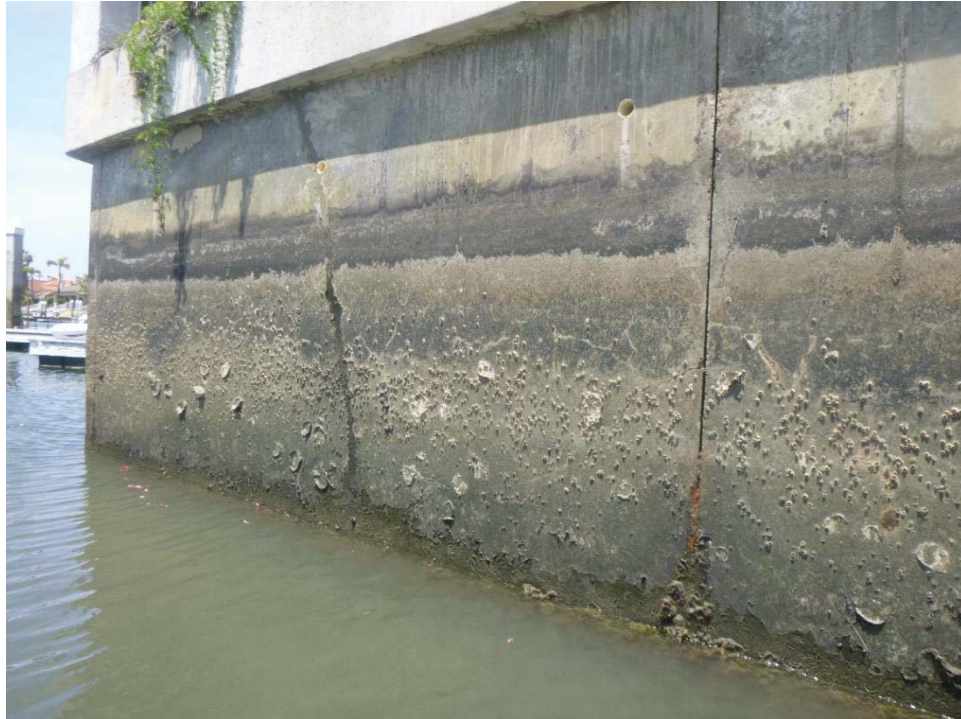
Photo 5: Blue Anchor Cay, Lot 4 southeast corner.
Minor spalling, west side of corner panel.

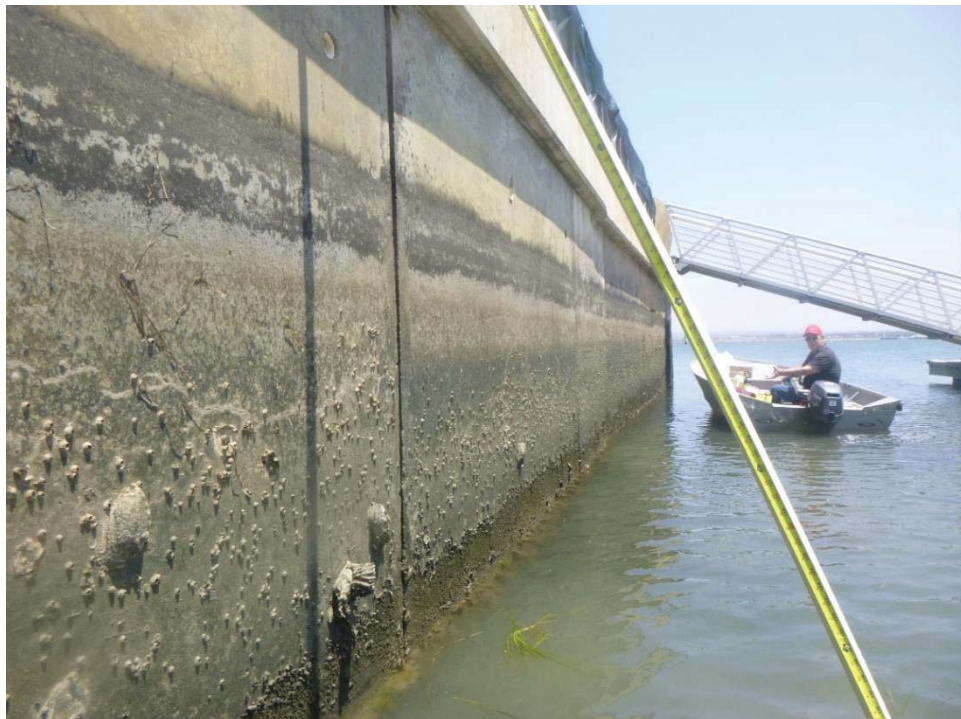
Photo 6: Blue Anchor Cay, Lot 3, Panel 5 from northeast corner.
Some wall separation at joint.

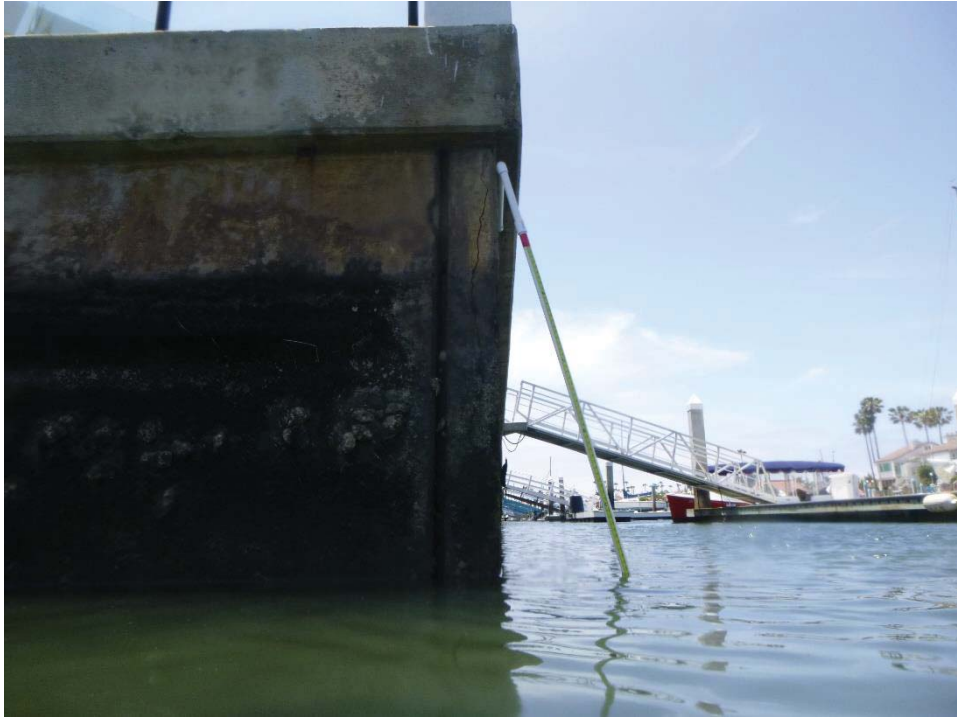
Photo 7: Blue Anchor Cay, large vertical crack along the northerly panel angle point on Lot 17. Northwesternly panel separating from adjacent easterly panel.

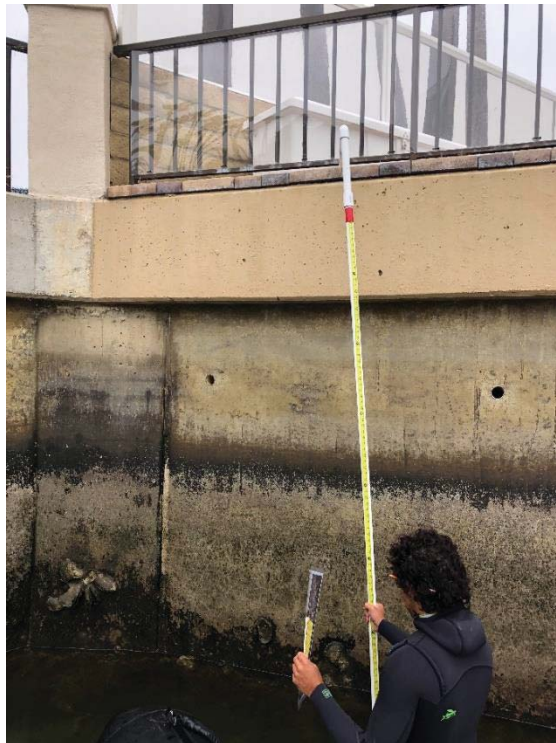
Photo 8: Spinnaker Way, second panel east of Lot 4/6 P/L. Vertical crack and spall.

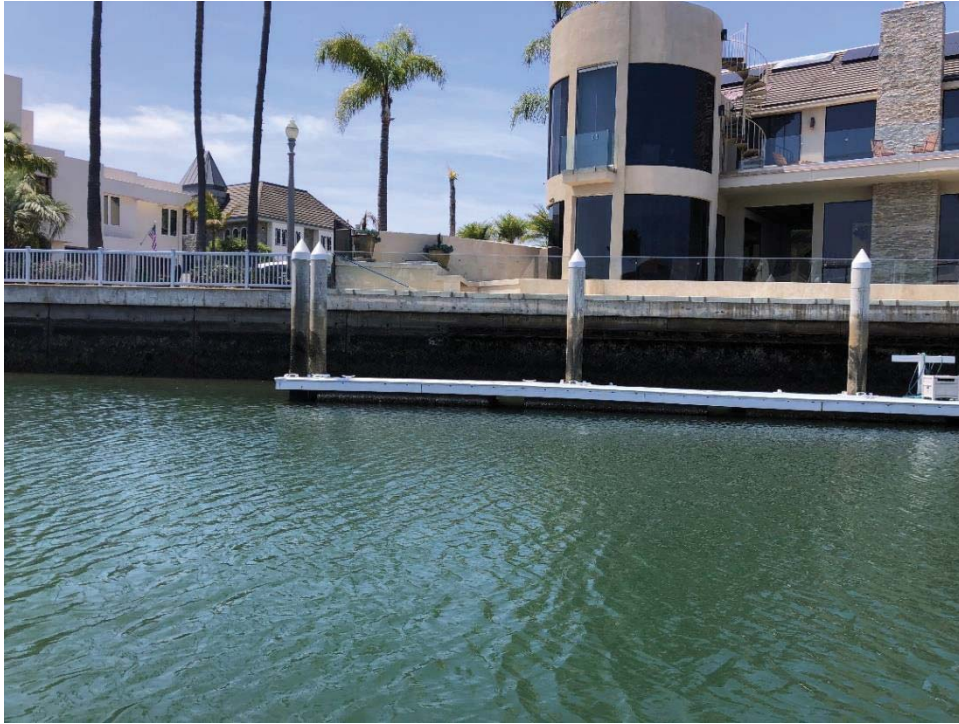
Photo 9: Spinnaker Way, north side of Lot 4.
Steel whaler on north side.

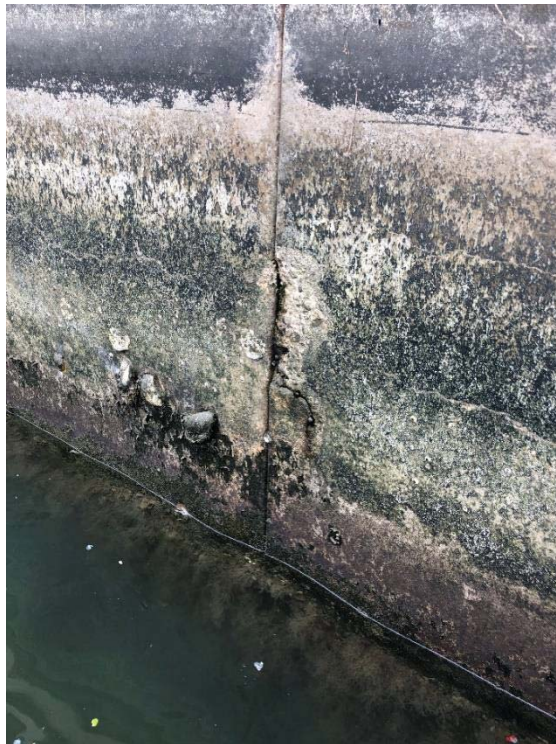
Photo 10: Spinnaker Way, north side of Lot 4.
Cracking and spalling

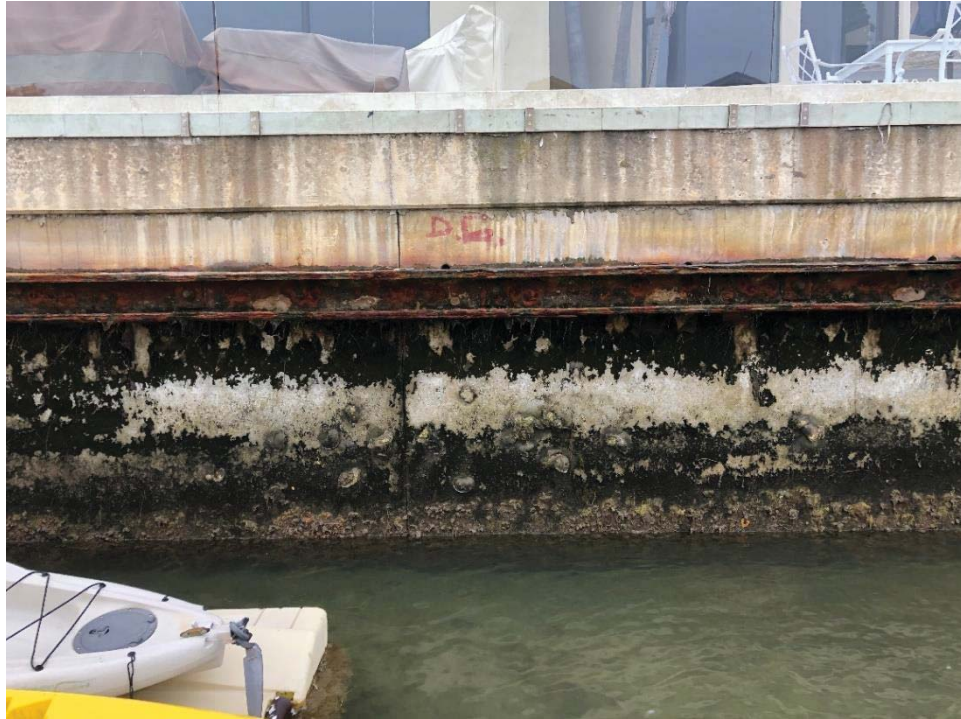
Photo 11: Spinnaker Way, north side of Lot 4.
Steel whaler is badly corroded.
