APPENDIX I

TERRACOSTA CONSULTING GROUP 3890 MURPHY CANYON ROAD, SUITE 200 SAN DIEGO, CA 92131 (619) 573-8900		FIGURE NUMBER I-1
CORONADO CAYS BULKHEADS		PROJECT NUMBER T3904.070.001
		<p>Field Survey Dates: May 18, 19, & 20, and June 25, 2021</p>

CORONADO CAYS BULKHEADS

Spinnaker Way East

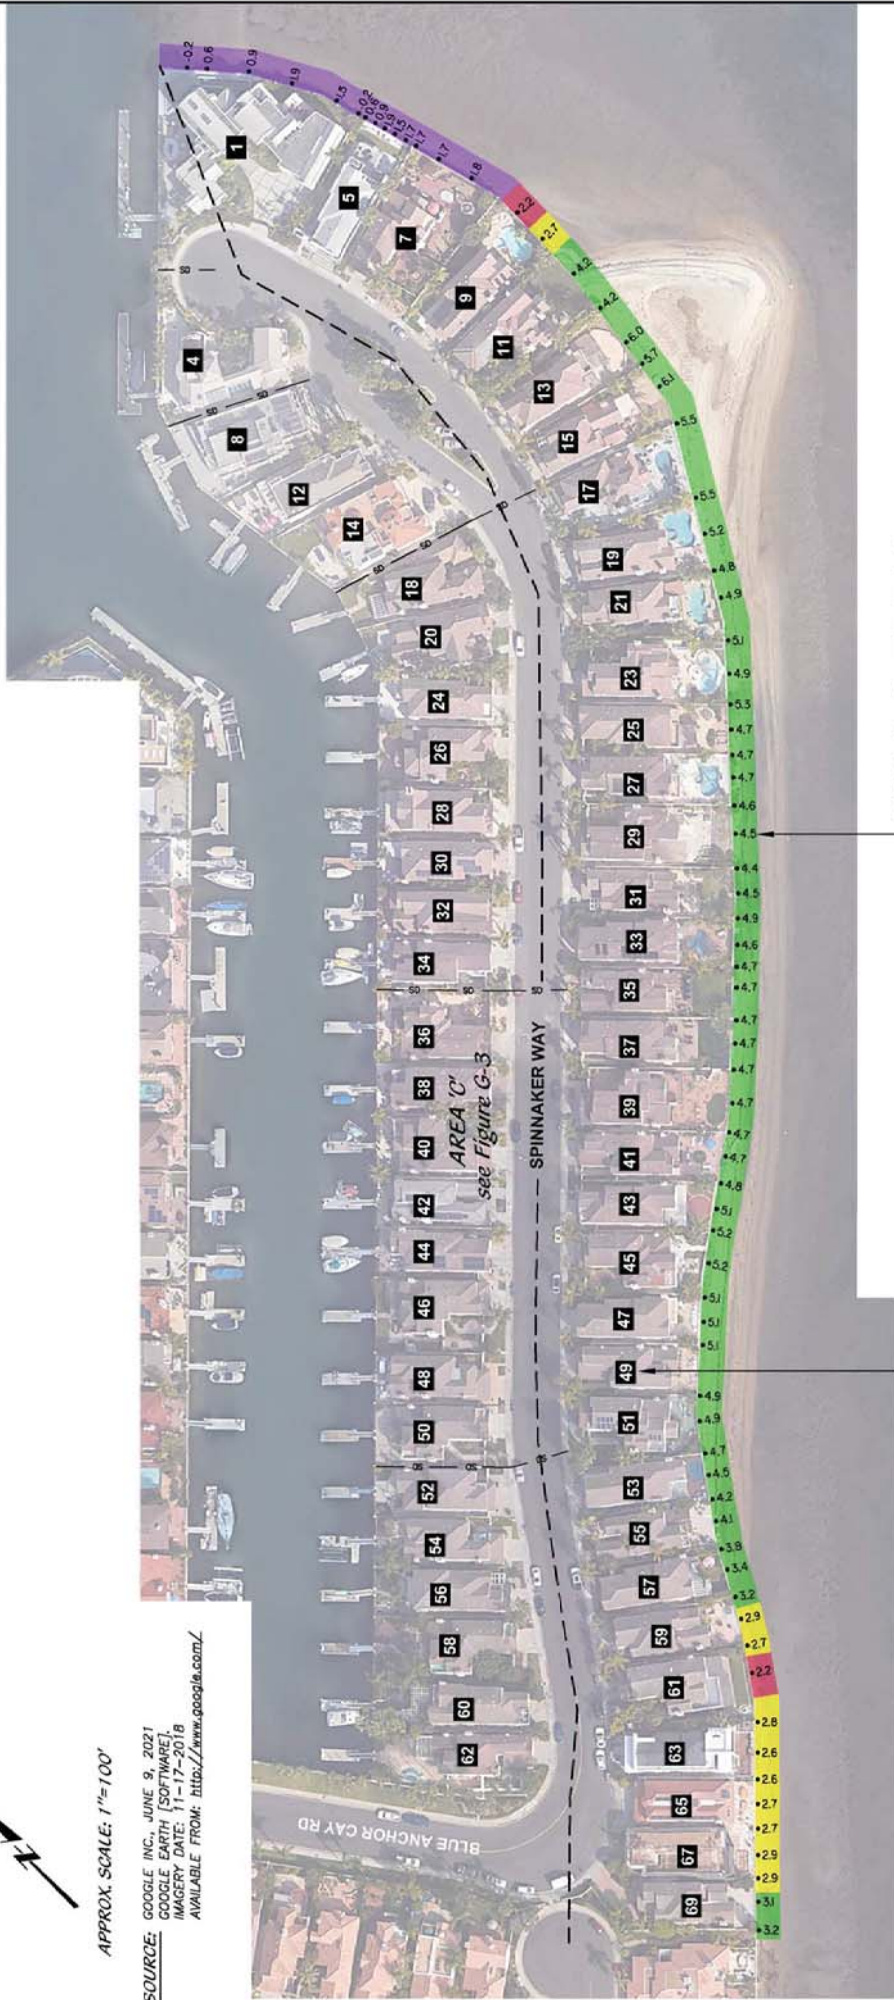
2021 Reading of berm elevation (typ.)

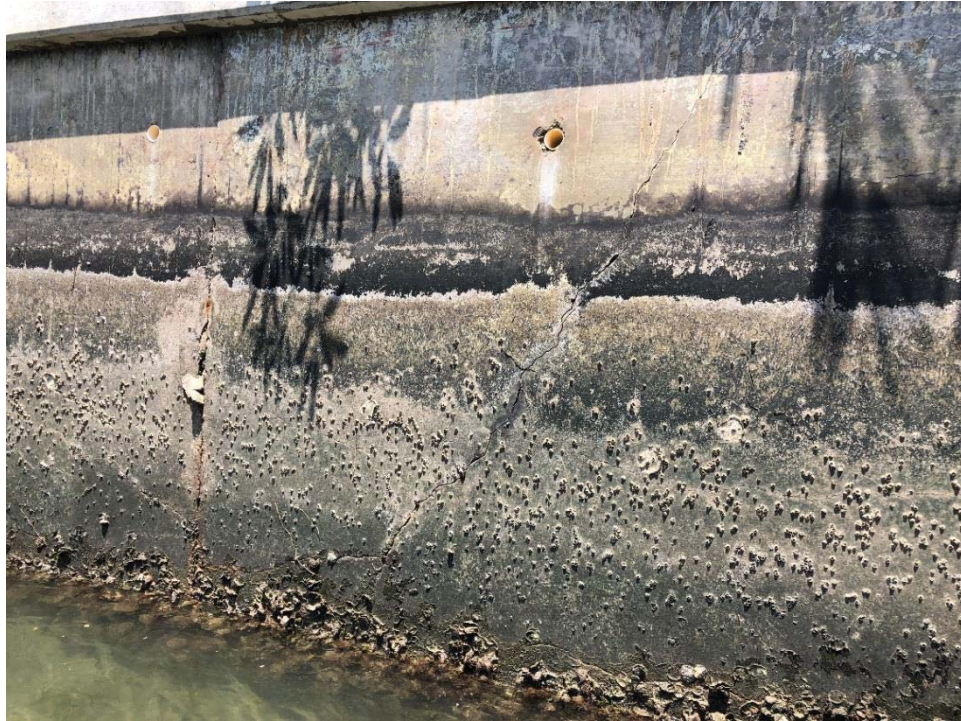
Photo 1: Spinnaker Way, Lot 5.
Cracks in eastern panel.

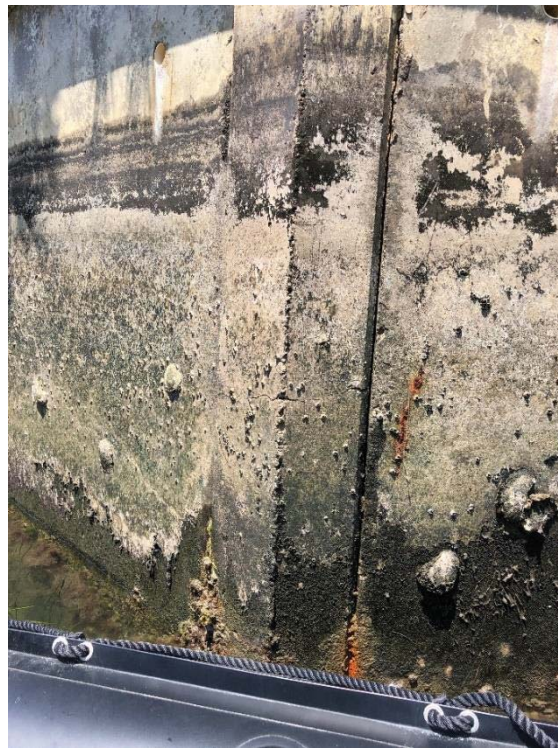
Photo 2: Spinnaker Way, Lot 1.
Corner panel has horizontal crack.
