APPENDIX J

Port Royale Village

TERRACOSTA CONSULTING GROUP 3890 MARIN CANYON ROAD, SUITE 200 SAN DIEGO, CA 92131 (858) 572-8900	FIGURE NUMBER J-1
	PROJECT NAME CORONADO CAYS BULKHEADS	PROJECT NUMBER T2004.070.001

CORONADO CAYS BULKHEADS

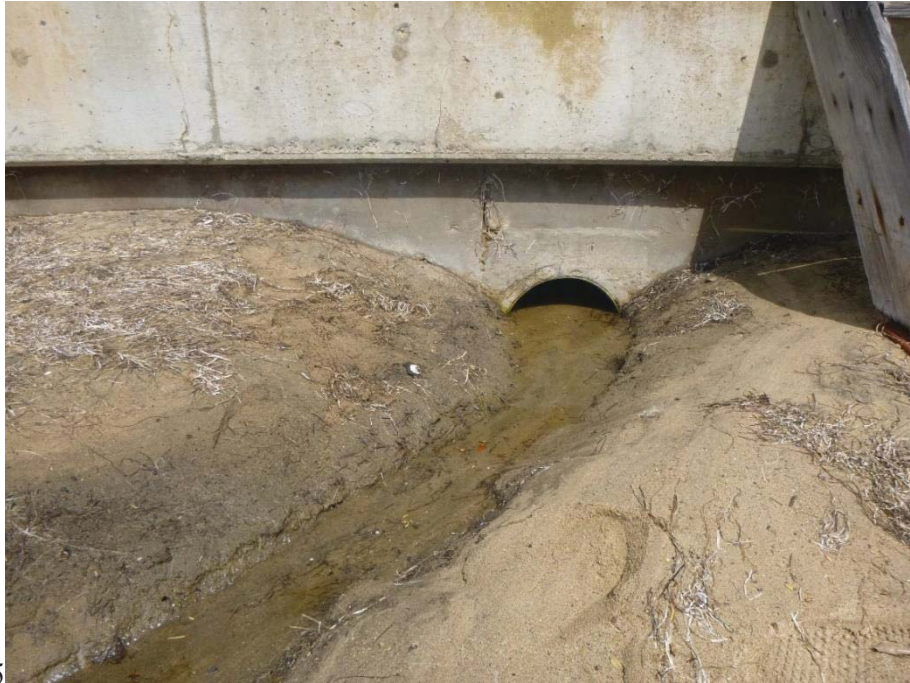
Photo 1: Port Royale Village between Lots 45 and 51.

Storm drain penetration is either 18 or 24-inch and lined with CIPP; storm drain is filled approx.. 75% with sand and a channel (either hand dug or naturally incised) exits the pipe, three vertical cracks in pile cap.

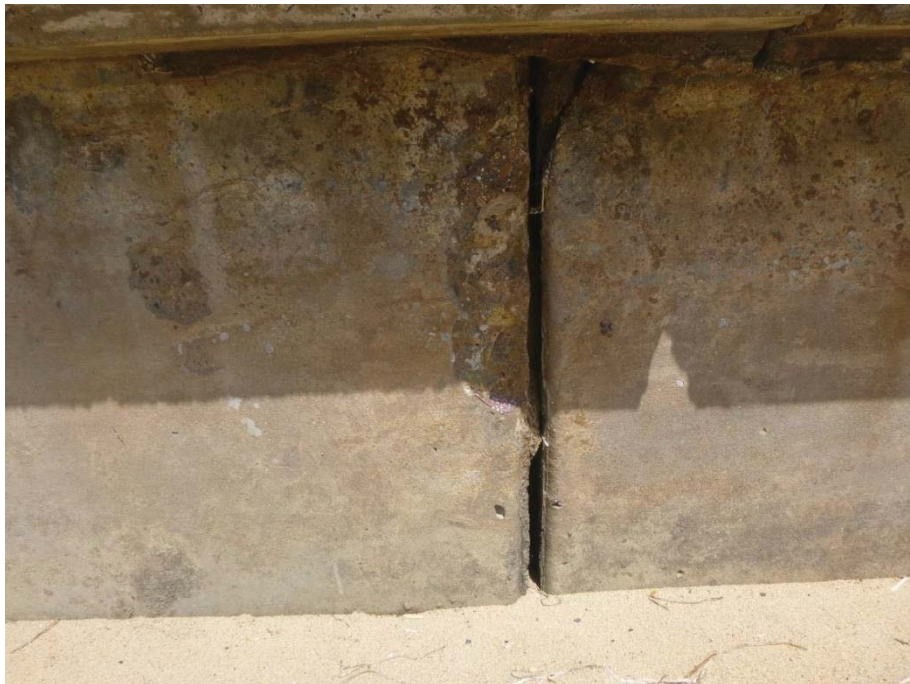
Lot 25	--	7 vertical cracks, 1 significant crack above the spalling panel joint, and 8 minor vertical cracks in pile cap. 2 minor vertical cracks in panels. Spalling at panel joint.
Lot 25/HOA PL	3.3	Spalling and cracking at pile cap joint with minor cracks in stucco pillar.
HOA	--	4 vertical cracks in pile cap. 1 minor diagonal crack in panel. No storm drain outlet penetration is visible. 3 2" pvc weep holes. Approximately 1" vertical settlement in pavers behind pile cap
HOA/Lot 21 PL	3.2	
Lot 21	--	5 vertical cracks in pile cap. 1 minor vertical crack in panel.
Lot 21/19 PL	3.2	Cracks extend from pile cap through stucco in the pillar at the end of the privacy wall
Lot 19	--	3 vertical cracks in pile cap. 2 minor vertical cracks in panel
Lot 19/17 PL	3.1	
Lot 17	--	5 vertical cracks in pile cap. 2 minor vertical cracks in panel. Northern panel joint is offset and spalling, and has approximately 2" aperture with a deteriorating patch

Photo 2: Port Royale Village, Lot 25.
Significant crack above spalling panel joint.

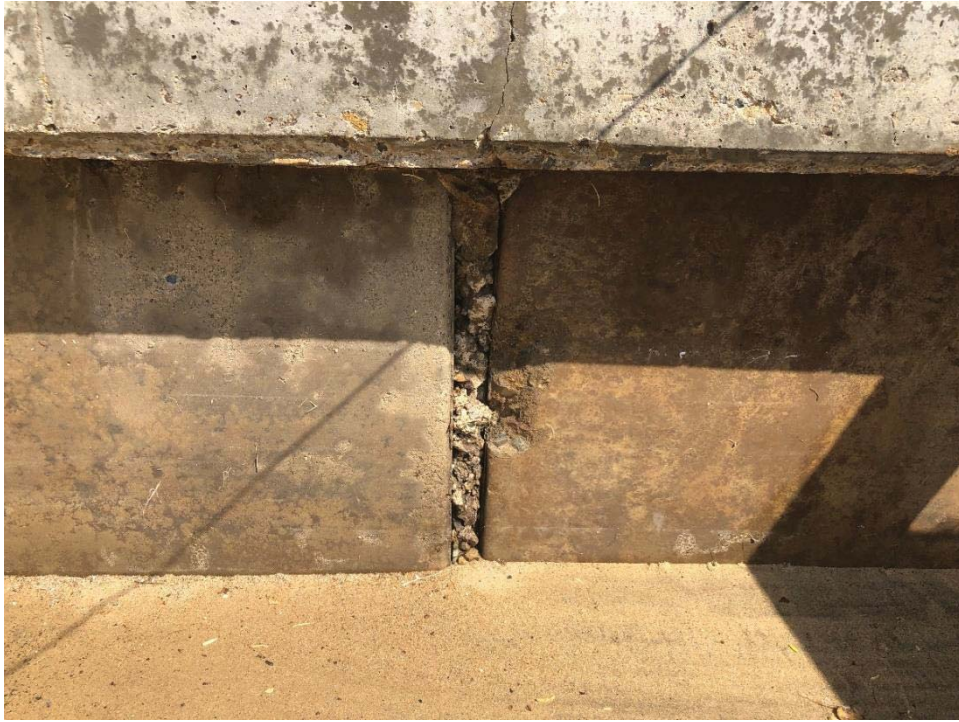
Photo 3: Port Royale Village, Lot 17.
Northern panel joint offset and spalling, approx.. 2-inch aperture with deteriorating patch.

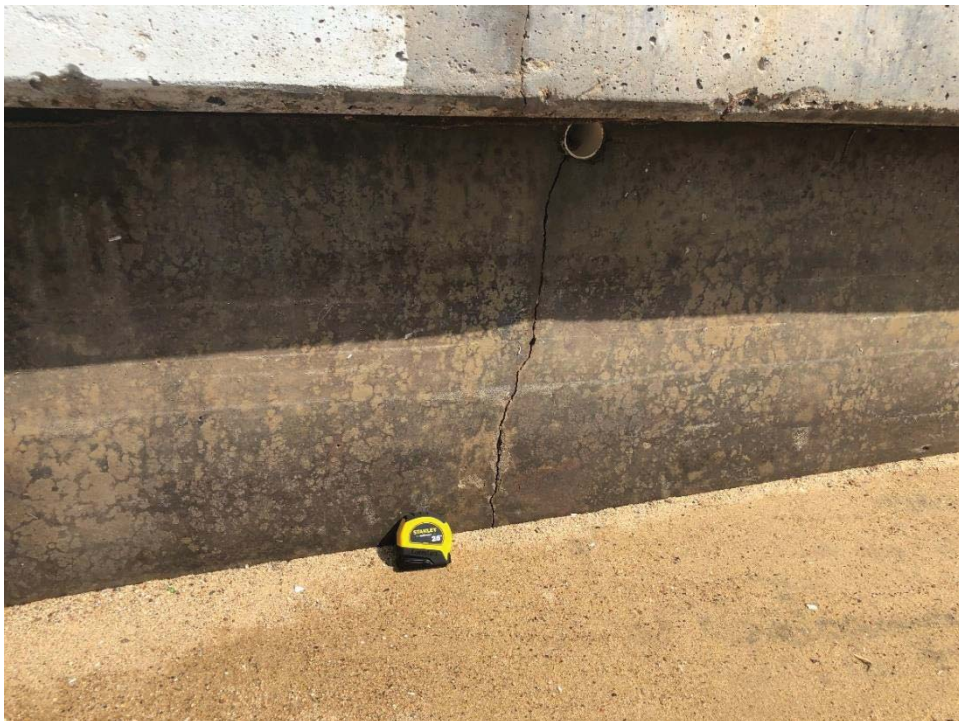
Photo 4: Port Royale Village between Lots 9 and 13.
One vertical crack and two minor vertical cracks in panel.
