APPENDIX K

Mardi Gras Village

TERRACOSTA CONSULTING GROUP 3880 MURPHY CANYON ROAD, SUITE 200 SAN DIEGO, CA 92131 (619) 973-8950	FIGURE NUMBER K-1
	CORONADO CAYS BULKHEADS	PROJECT NUMBER T2004.070.001
		MARDI GRAS VILLAGE

CORONADO CAYS BULKHEADS

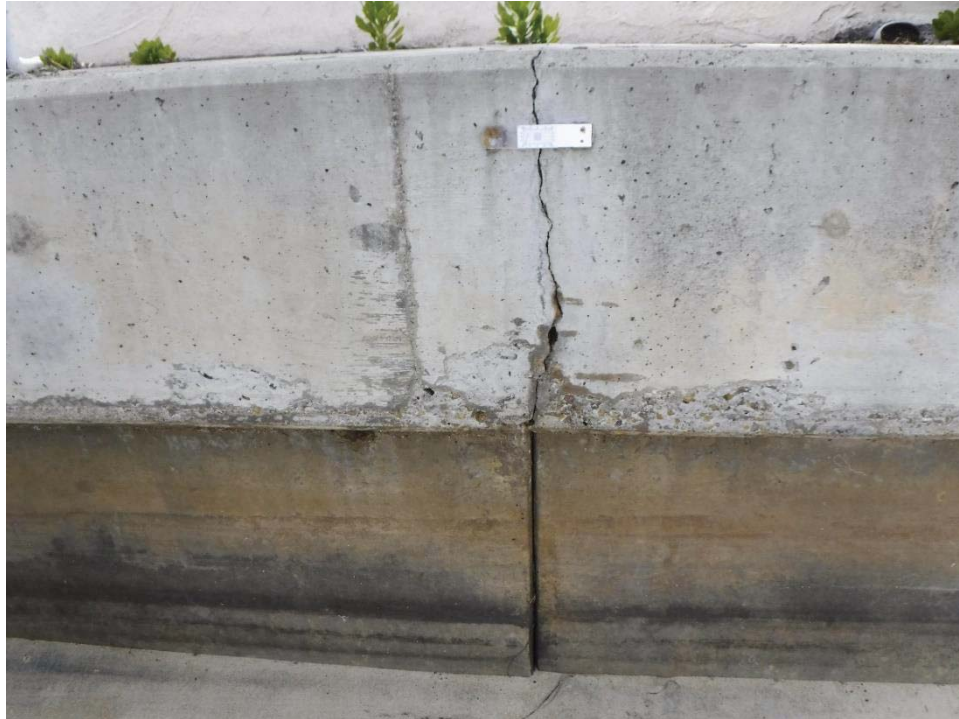
Photo 1: Mardi Gras South, Lot 67.
Vertical cracks above panel joint.

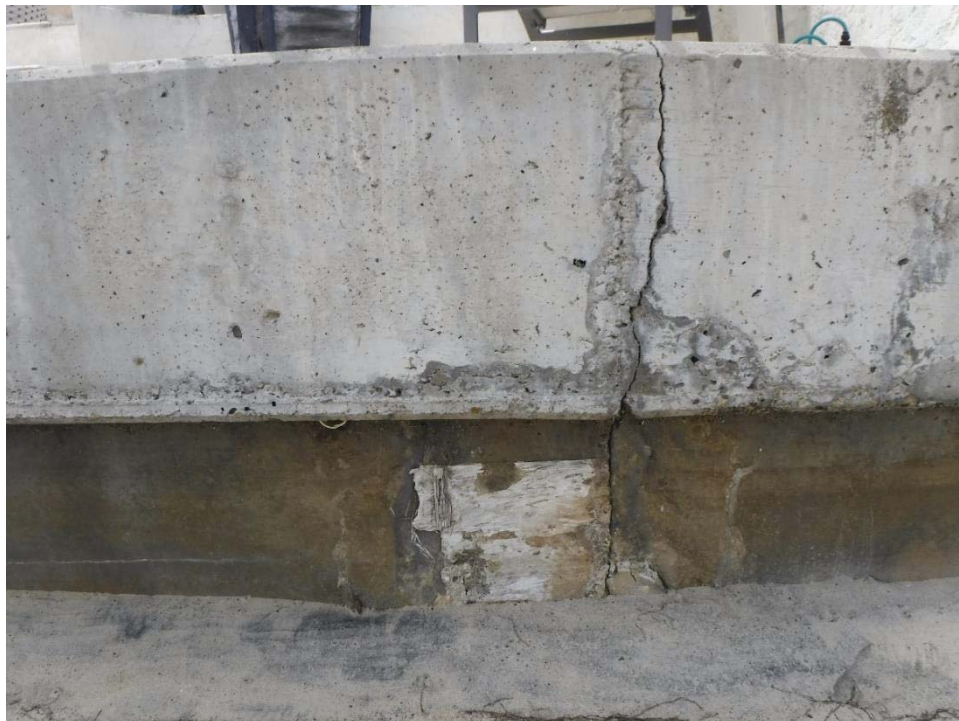
Photo 2: Mardi Gras South, Lot 59.
Diagonal panel crack.

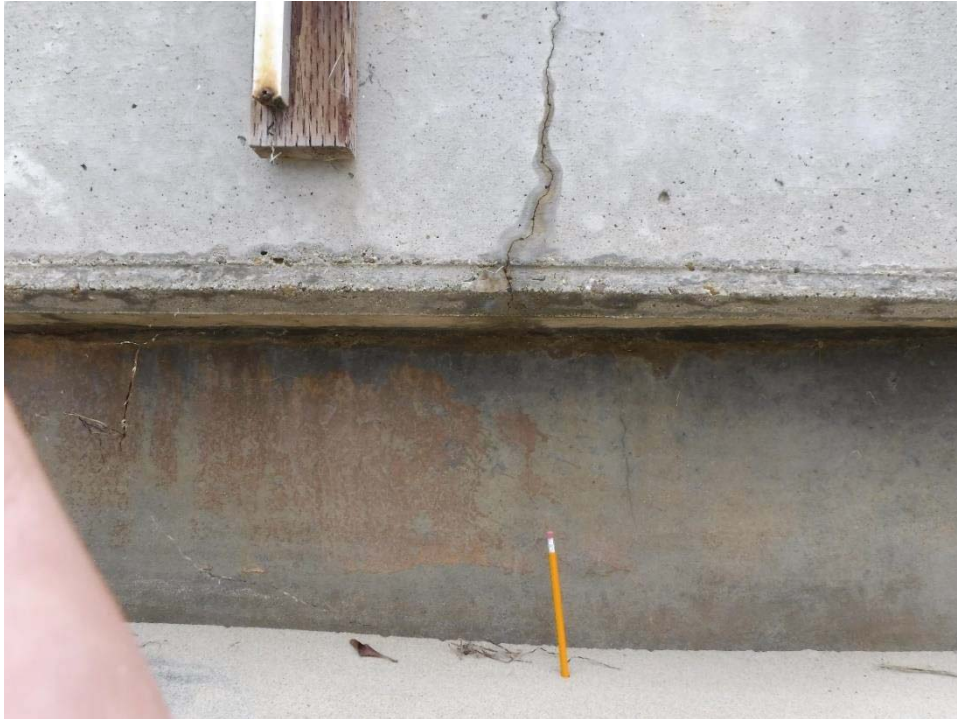
Photo 3: Mardi Gras South, Lot 37.
Diagonal crack with light rust staining on panel cap.

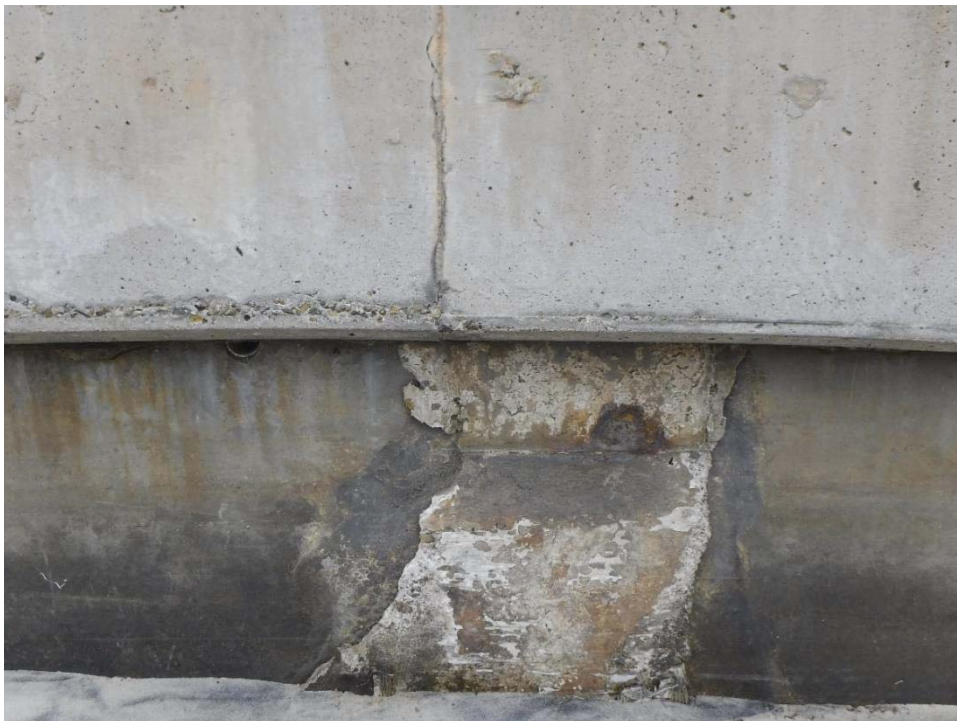
Photo 4: Mardi Gras South, Lot 35.
Concrete spalling where bulkhead turns approximately 15 degrees.

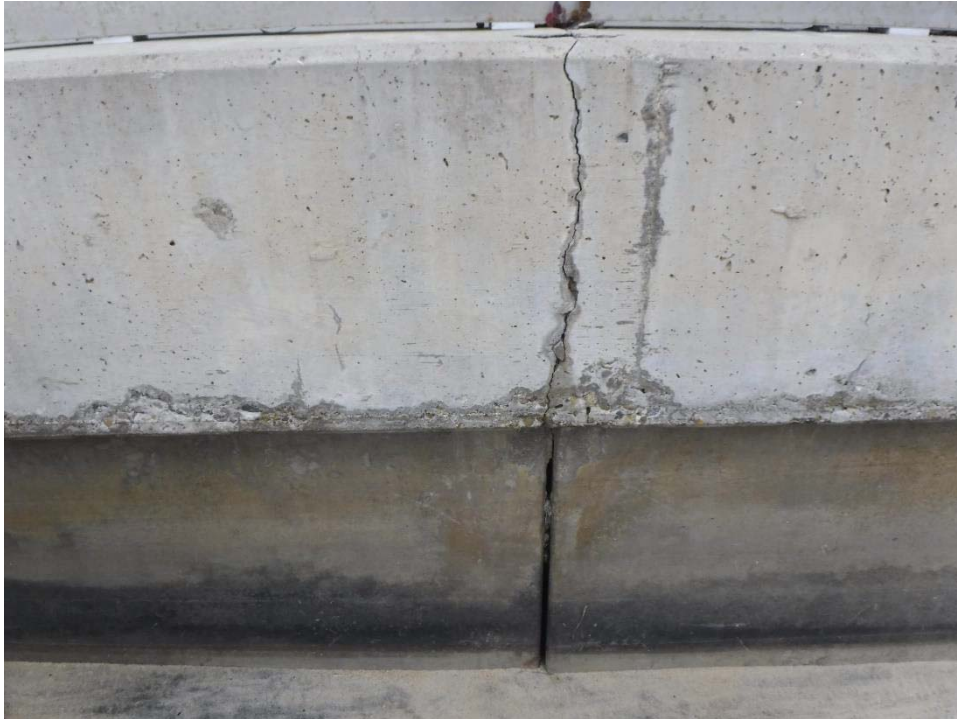
Photo 5: Mardi Gras North, Lot 27.
North side of lot has significant crack and spalling.

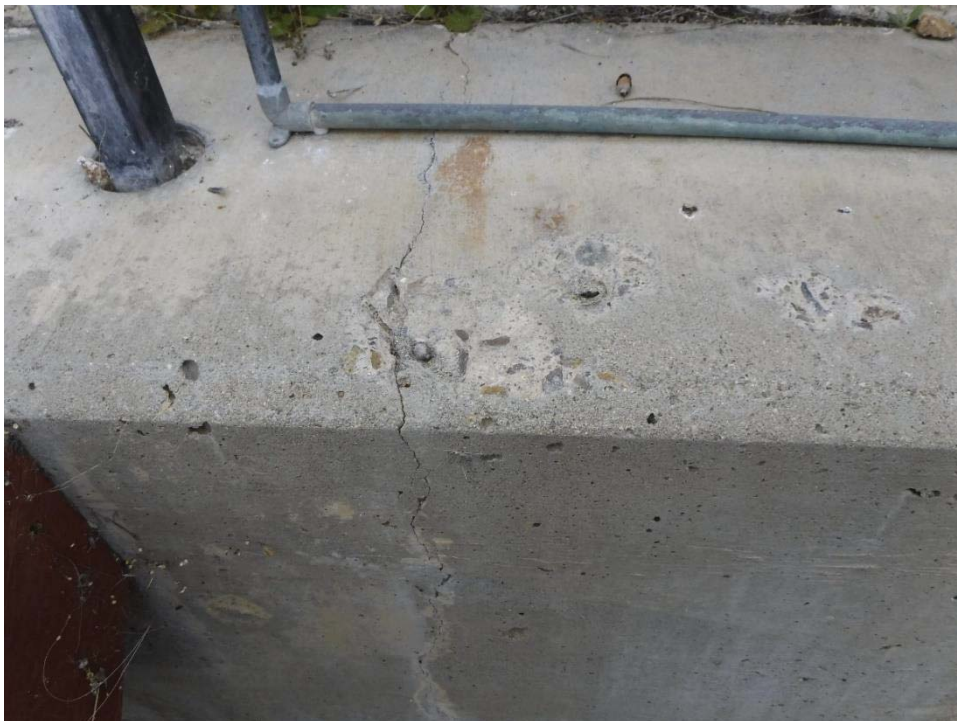
Photo 6: Mardi Gras North, Lot 25.
Cracking in pile cap.

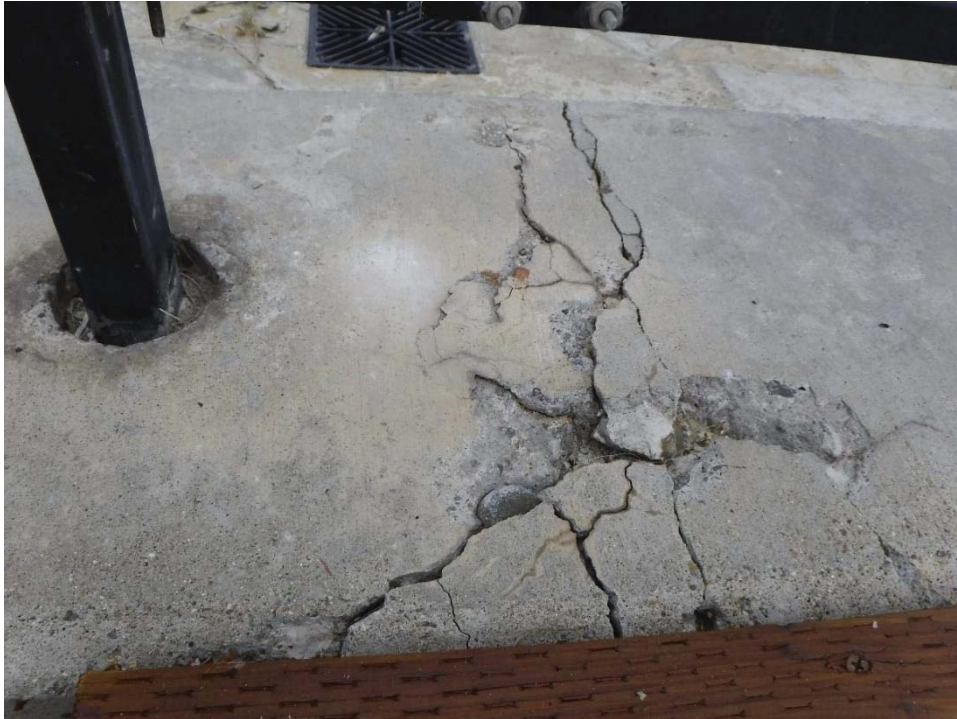
Lot 25/23 PL	2.6	
Lot 23	--	2 2" pvc weep holes. Hole with rust on panel. 5 vertical cracks and 6 minor vertical cracks in pile cap. 1 of the cracks in the pile cap has approximately 3/8" aperture and the concrete is breaking apart. 7 minor vertical cracks in panels. Up to approximately 1/2" separation between pavers and back of pile cap.
Lot 23/21 PL	2.6	Stucco is cracked between privacy wall and pillar at property line.
Lot 21	--	10 vertical cracks and 10 minor vertical cracks in pile cap. 7 minor vertical cracks in panels. Minor cracks commonly have white mineralization. Panel joint near southern property line has approximately 3/4" offset
Lot 21/HOA PL	2.3

Photo 7: Mardi Gras North, Lot 23.
Cracks in pile cap have approx.. 0.375 inch aperture; concrete is breaking apart.

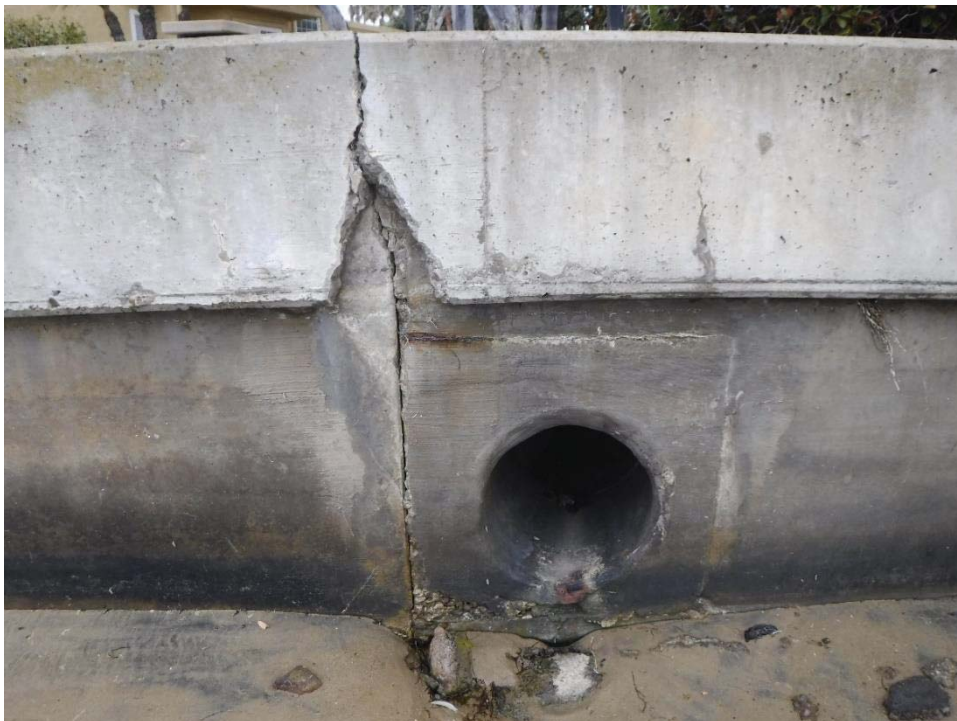
Photo 8: Mardi Gras North, Storm Drain between Lots 17 and 21.
Pile cap above storm drain penetration has significant crack; concrete is broken and missing.
