**CORONADO CAYS DEVELOPMENT**  
CORONADO, CALIFORNIA

**GEOTECHNICAL ASSESSMENT OF BULKHEADS  
AND THEIR ASSOCIATED ENGINEERING ELEMENTS**

August 26, 2021  
**Revised:** September 17, 2021

PROJECT NO.  
T2904.070.001

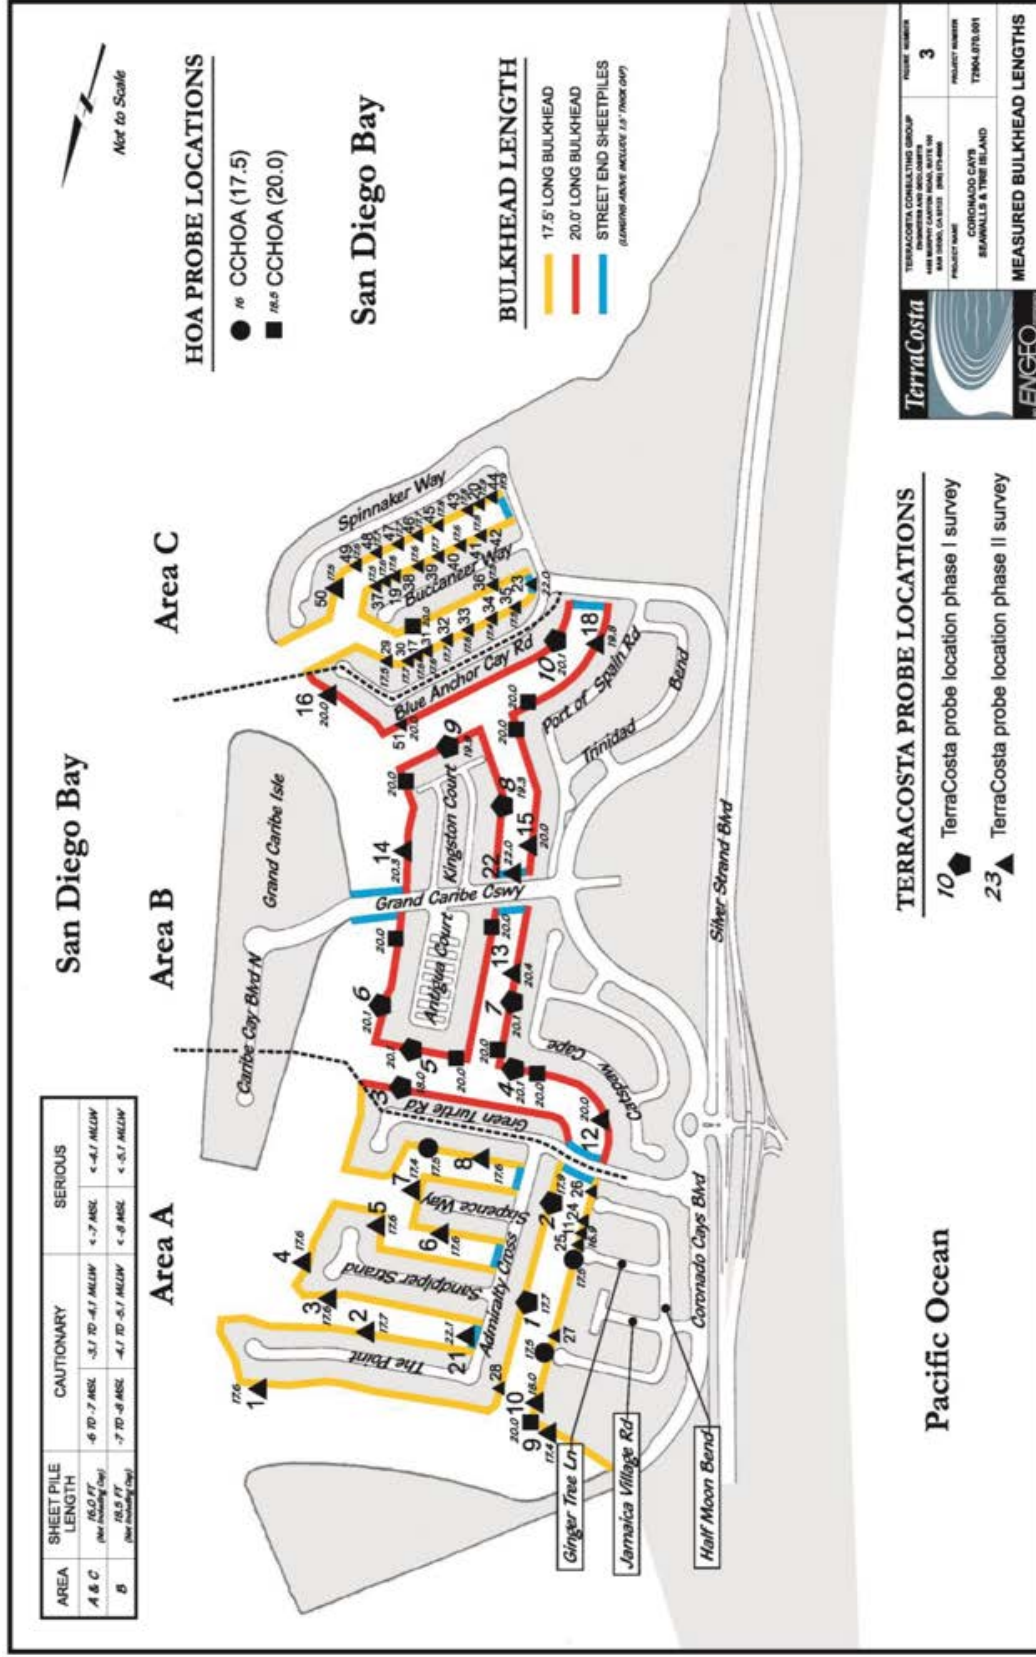
For our analyses, we have utilized the same designation criteria that was established in our 2006 report as a means of identifying areas that are cautionary and serious. Cautionary soil berm elevation thresholds for 17.5-foot long bulkheads (Areas A and C, Figure 3) are between -6 and -7 feet, Mean Sea Level (-3.1 and -4.1 feet MLLW). Serious soil berm elevation thresholds for 17.5-foot long bulkheads (Areas A and C, Figure 3) are below -7 feet, Mean Sea Level (-4.1 feet MLLW).

Likewise, cautionary soil berm elevation thresholds for 20-foot long bulkheads (Area B, Figure 3) are between -7 and -8 feet, Mean Sea Level (-4.1 and -5.1 feet MLLW). Serious soil berm elevation thresholds for 20-foot long bulkheads (Area B, Figure 3) are below -8 feet, Mean Sea Level (-5.1 feet MLLW).

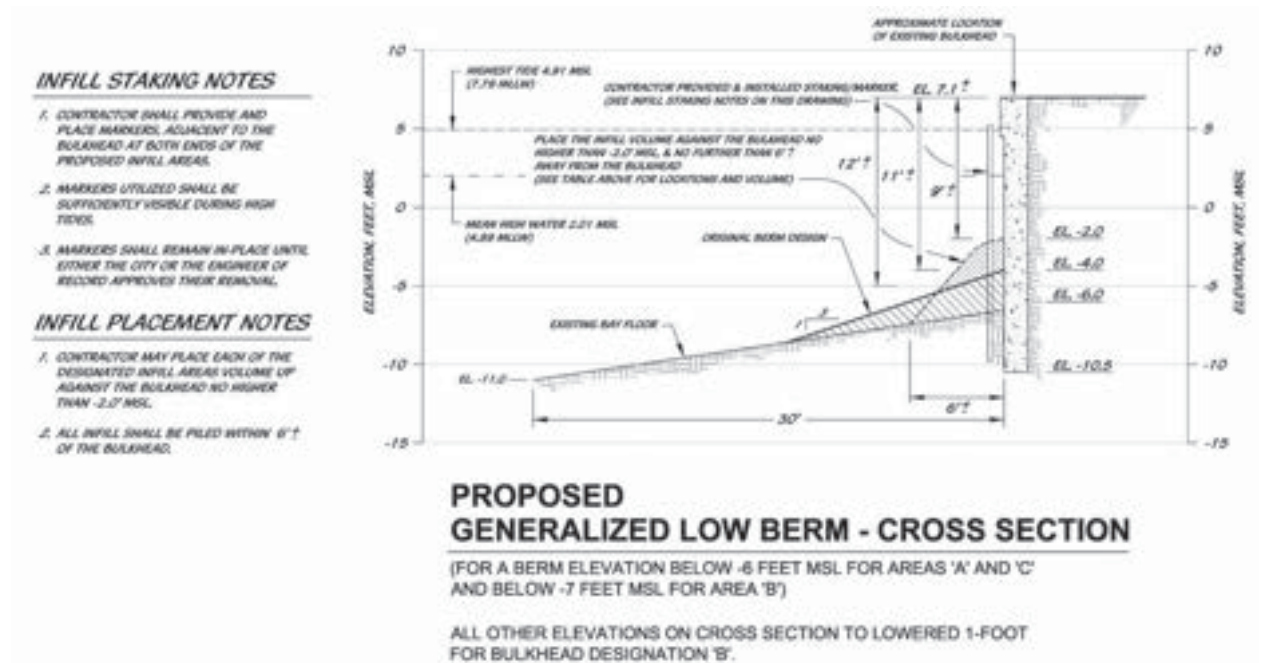
Figure 4 – Proposed Generalized Low Berm – Cross Section

As indicated previously, there are no berm elevations within the interior fairways of the Coronado Cays resulting in a designation of “serious.” There are, however, several areas where the berm elevations are low enough to warrant a “cautionary” designation, and these areas should be stabilized. Figure 4 presents the proposed stabilization approach for any “cautionary” (or “serious”) berm elevations. The proposed maintenance infill volumes for various lots are presented in Table 1.

With regard to berm stability, we recommend lots designated as “cautionary” and “serious” (Table 1), have their soil berm buttresses restored to prevent catastrophic failure. We believe these bulkheads have a static factor of safety of less than 1.5 and that increasing the passive resistance of the bulkheads will be necessary to prolong the life of these walls.
