APPENDIX H

Blue Anchor Cay

CORONADO CAYS BULKHEADS

Project Number T2904.070.001

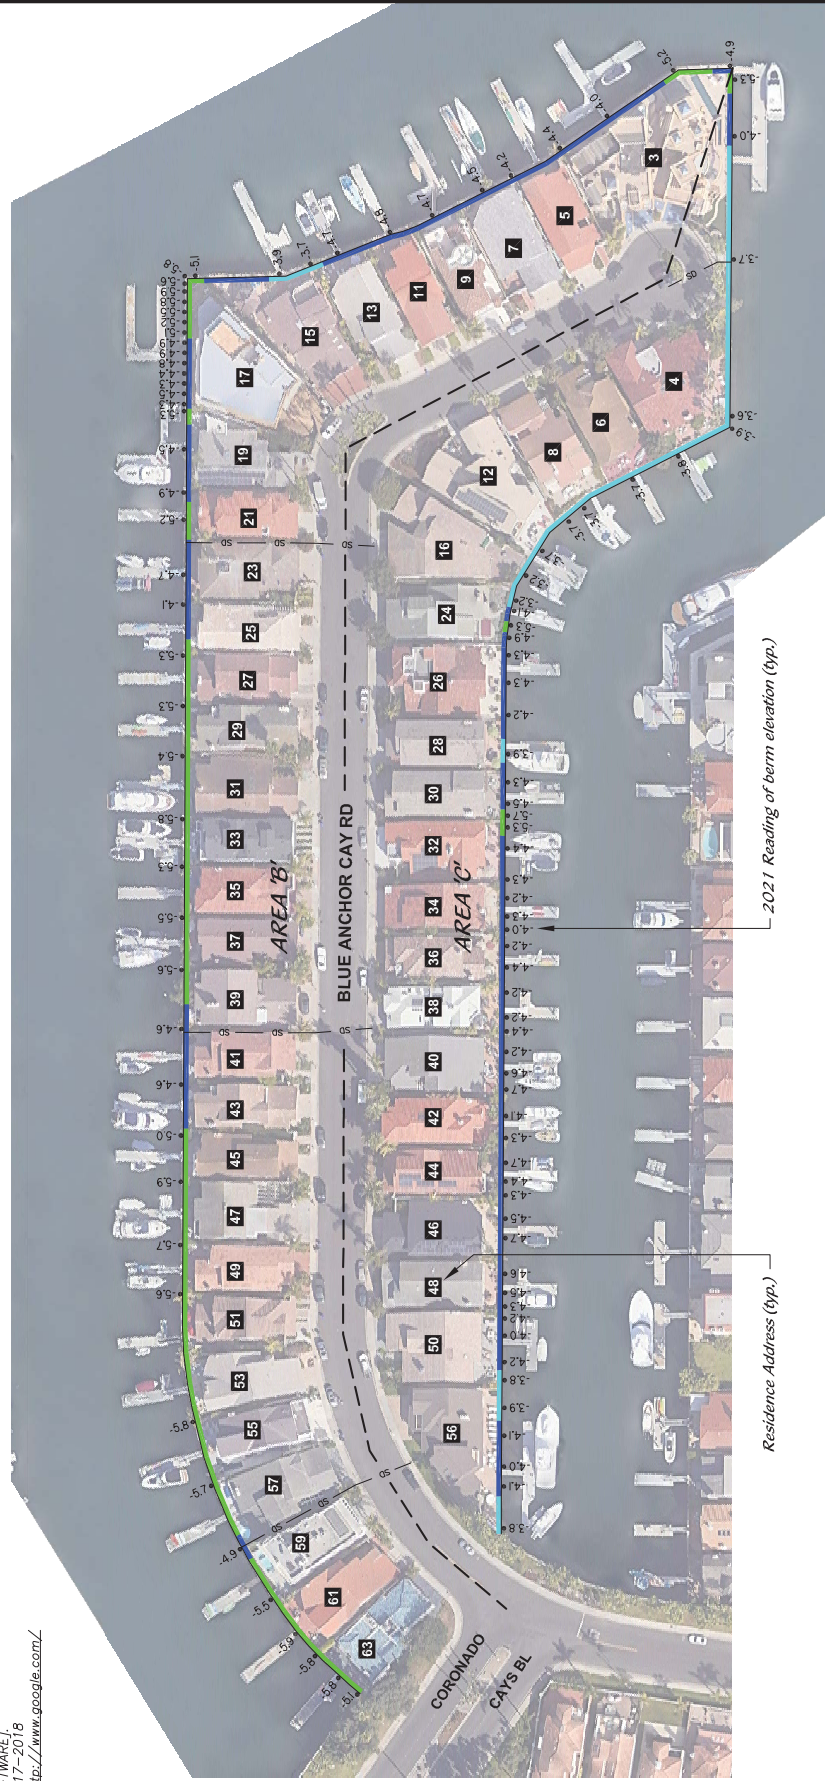
AREA	SHEET PILE LENGTH	CAUTIONARY	SERIOUS
B	20.0 FT (including Cap)	-7 TO -8 MSL	< -8 MSL
C	17.5 FT (including Cap)	-6 TO -7 MSL	< -7 MSL

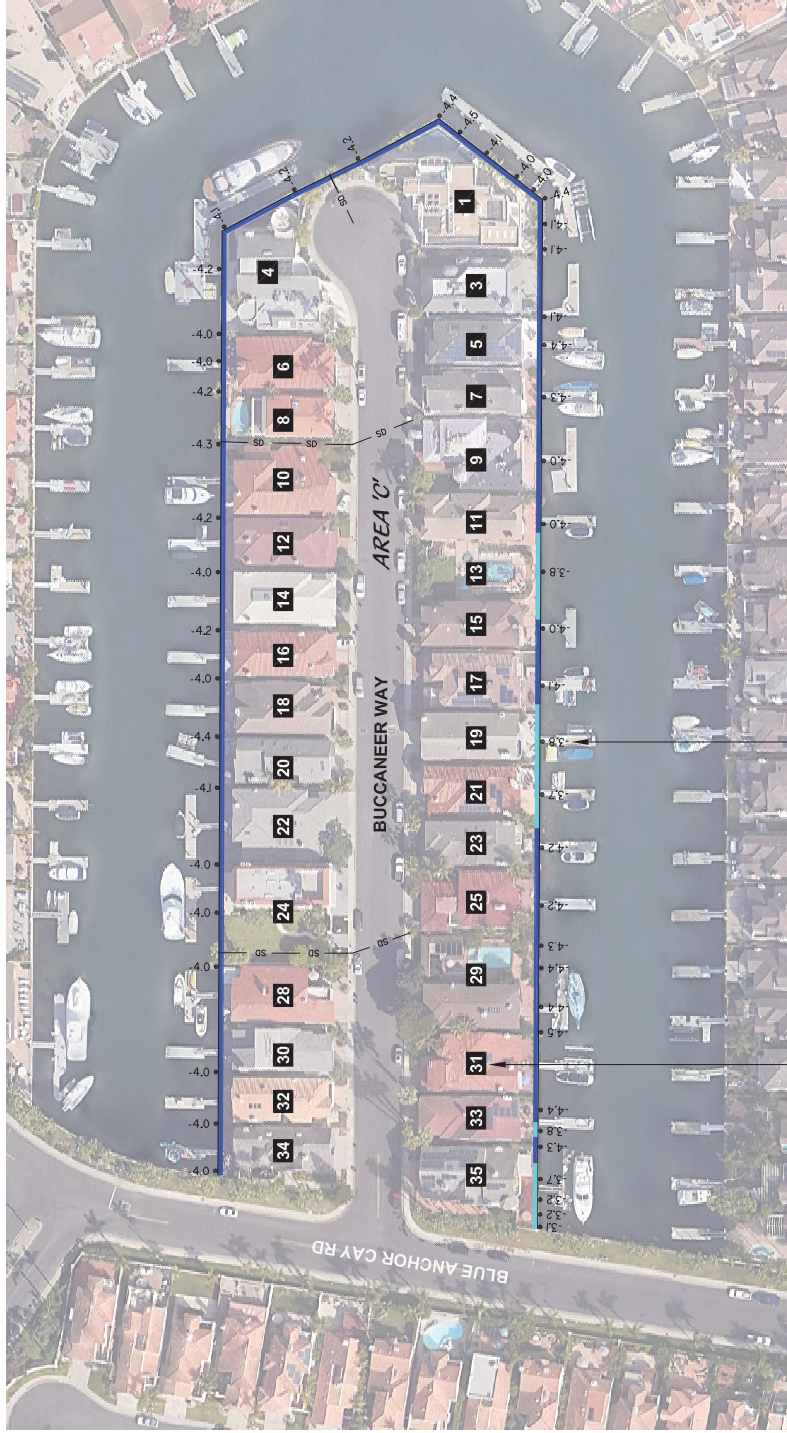
AREA	SHEET PILE LENGTH	CAUTIONARY	SERIOUS
C	17.5 FT. (including Cap)	-6 TO -7 MSL	< -7 MSL
