**CORONADO CAYS DEVELOPMENT**  
CORONADO, CALIFORNIA

**GEOTECHNICAL ASSESSMENT OF BULKHEADS  
AND THEIR ASSOCIATED ENGINEERING ELEMENTS**

August 26, 2021  
**Revised:** September 17, 2021

PROJECT NO.  
T2904.070.001

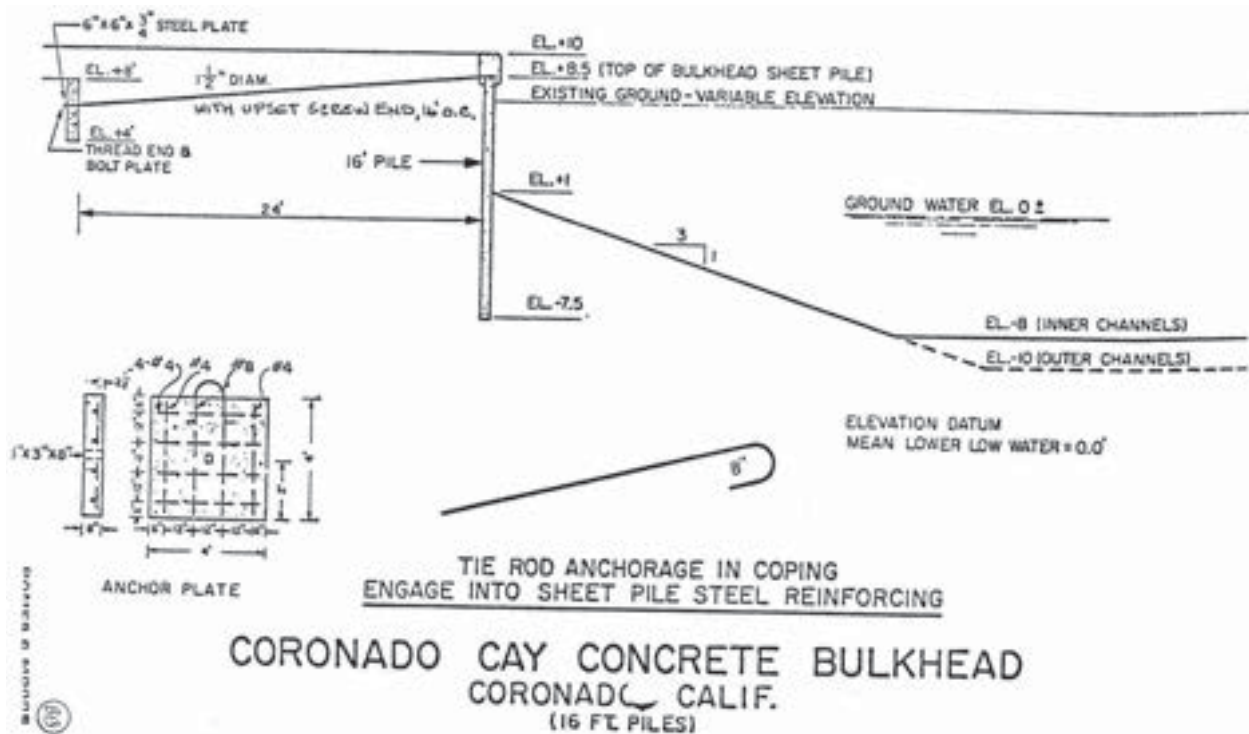
**Figure 2 – Original Bulkhead Design Section**

The design of bulkheads incorporated either a 17½- or a 20-foot-long concrete sheet piles fronting the private waterfront properties, and 22-foot-long concrete sheet piles along the various City of Coronado-owned causeways. The bulkheads also incorporated a 22-inch-high concrete pile cap. The sheet-pile cap elevation throughout the Cays was set at elevation +10 feet, mean lower low water (MLLW) datum (+7.12 feet Mean Sea Level (MSL) datum). The original design called for a passive soil berm extending from elevation +1 foot MLLW (or 9 feet below the top of the pile cap), at the base of the bulkhead, to elevation -8 feet MLLW at the channel bottom. The soil berms were designed to extend 27 feet from the bulkhead into the fairway at a slope inclination of 3:1 (horizontal to vertical). Beyond the soil berms, the channel bottom was designed as a flat cross section dredged to elevation -8 feet MLLW. In addition to the passive resistance provided by the berms, the bulkheads are also restrained with a series of deadman anchors along the top of the bulkhead (see Figure 2).

The concrete sheet-pile bulkheads throughout the Coronado Cays Development utilize a combination of tongue-in-groove or groove-in-groove joints between adjacent panels, with the joint, immediately after panel installation, flushed with water, then grouted solid with a cementitious grout. The integrity of the grout making joints waterproof is affected by initial contamination during construction; minor misalignments of adjacent joints during construction, exposing the grout to increased hydraulic and marine degradation; minor post-construction movement of the panels; and overall degradation of the cementitious grout mix over time.

The passive soil berms fronting the bulkheads play an important role in the long-term stability of the bulkhead. The bulkhead stability is a function of geotechnical soil parameters, differential water level, integrity of the steel-reinforced concrete panels, and, most importantly, the elevation and configuration of the berm providing passive resistance for the bulkhead. For the studies performed to date, the criterion of a minimum factor of safety of 1.5 against rotation failure about the bulkhead anchor has been used to assess the stability of the Cays bulkhead. Typically, the computation of the factor of safety is based on the ratio of moments of forces associated with resisting rotation, compared to moments of forces associated with driving rotation. The moments associated with driving, or causing, rotation are commonly referred to as overturning moments. Usually, the forces located landward of the bulkhead are related to causing rotation, whereas the forces located bayward of the bulkhead are associated with resisting rotation.
